**ACTION MEMORANDUM AMENDMENT 2**

**SUBJECT:** Request for a Ceiling and Scope Increase and Continued Exemption from the 12-month and \$2 million Statutory Limits for Removal Action at the Nelson Tunnel/Commodore Waste Rock Site in Mineral County, Colorado

Site ID# 08MB

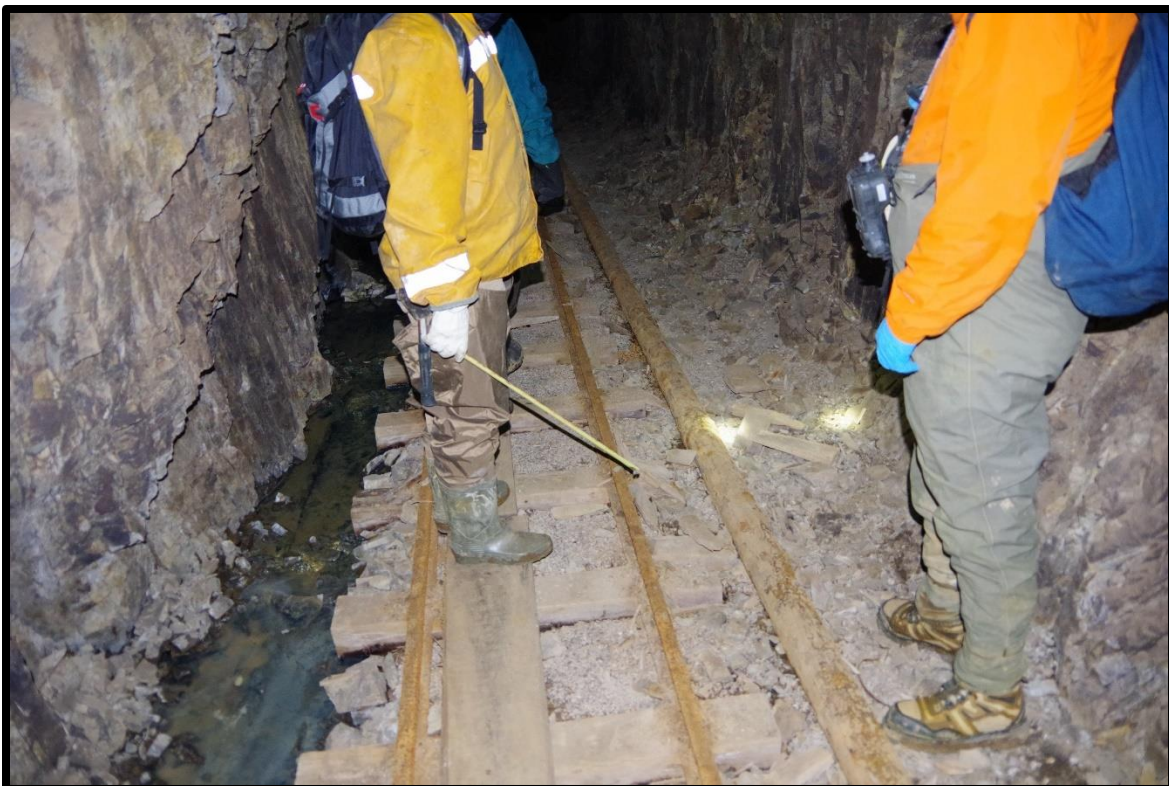
**Photo 8: Typical rail, ditch, and invert in Commodore 5 Cross Cut**

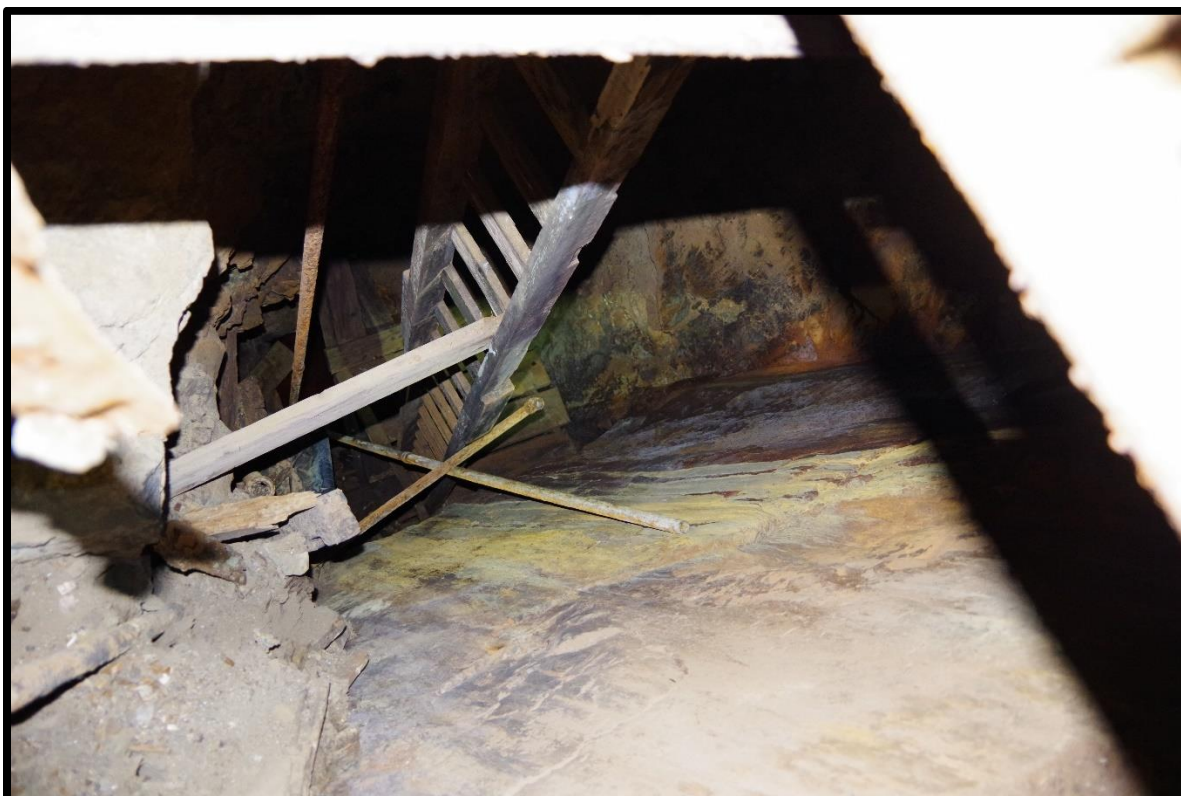
Photo 18: Looking down Daylight Winze: Note smooth footwall, ladder, and landing

Significant work is also needed at the Daylight Winze and the raise above it. Due to its importance of acting as the last drain into the Nelson Tunnel, the Daylight Winze should be fully rehabilitated by scaling, bolting, and installing new ladders and landings made of non-decaying or corroding material such as fiber reinforced plastic (FRP). This work would take place above the Nelson Tunnel without impacting the impounded mine pool areas. A cover capable of supporting vehicle traffic and allowing water inflow should also be installed. We anticipate the cover consisting of a concrete collar with coated steel beam supports and grated FRP cover.

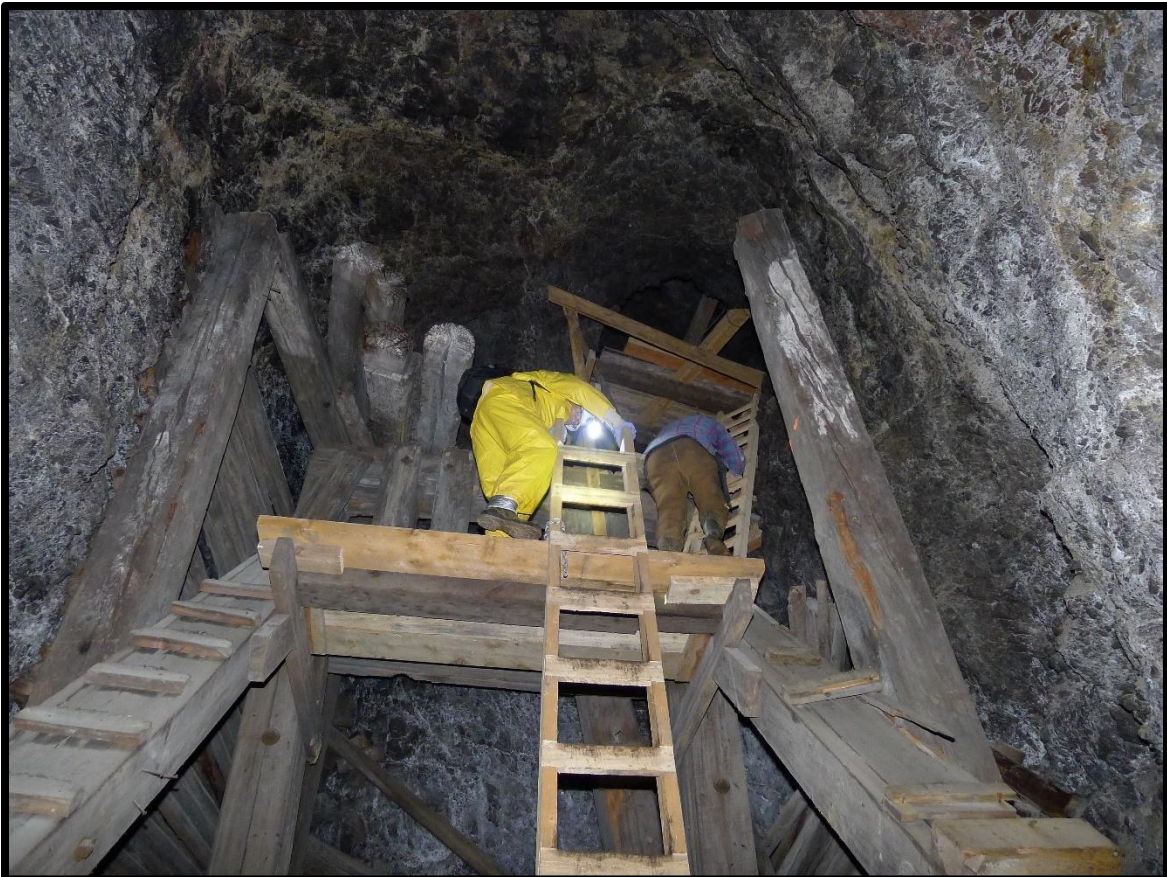
Photo 28: : Bachelor Shaft looking up to second landing

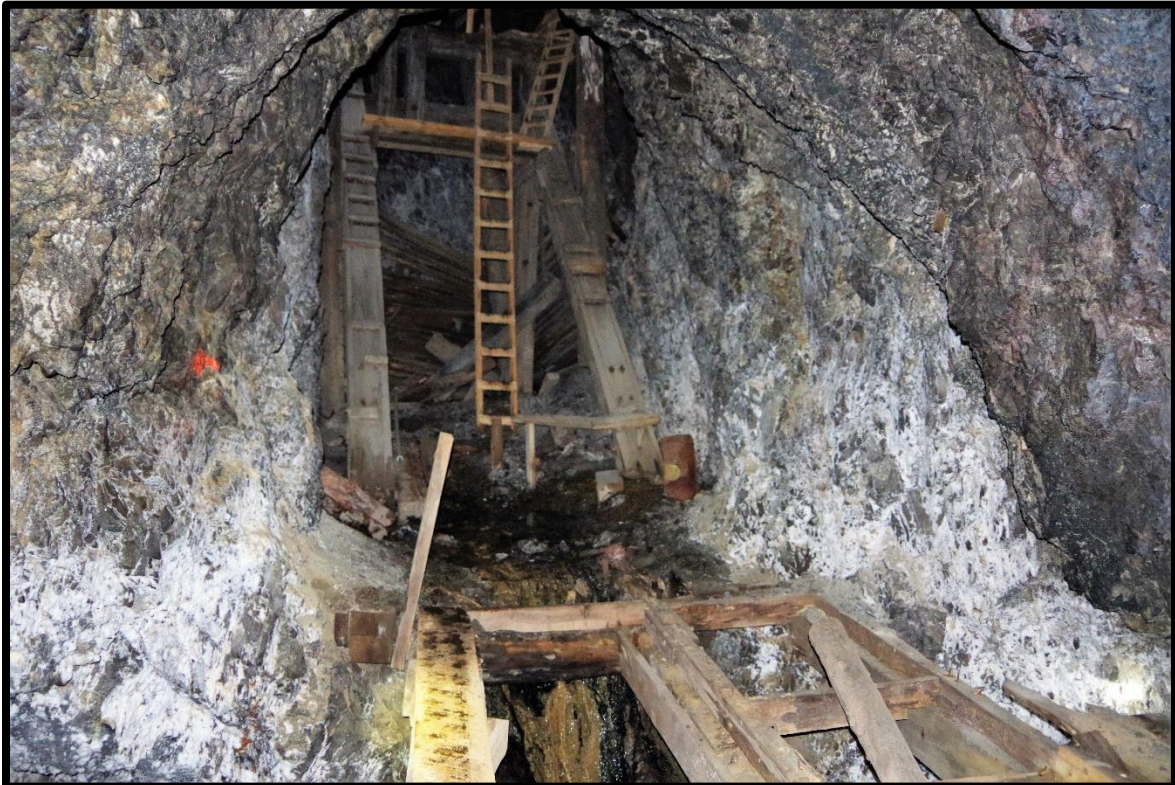
**Photo 29: Bachelor Shaft bottom and second landing seen from far side of Nelson Tunnel**

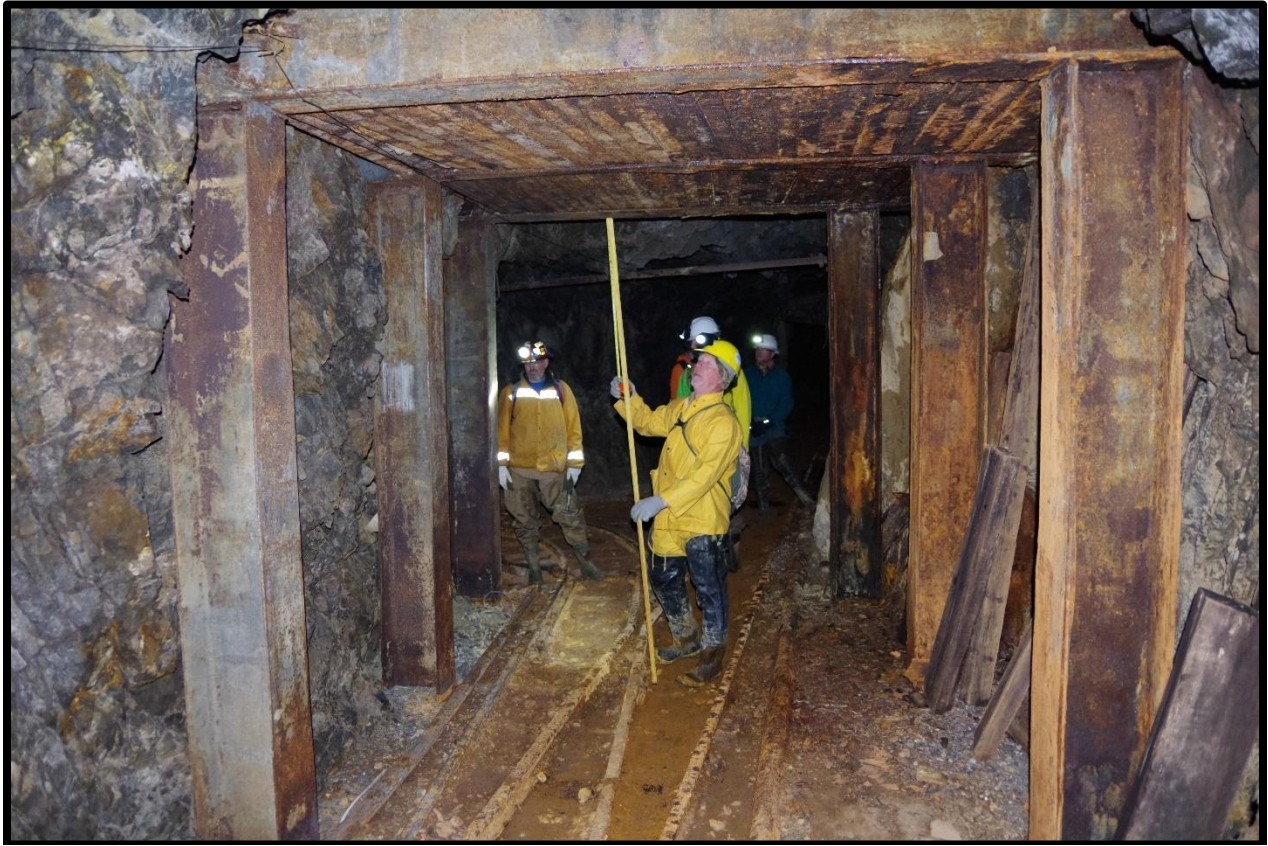
**Photo 33: Measuring Archimedes Raise dimensions 26+64**

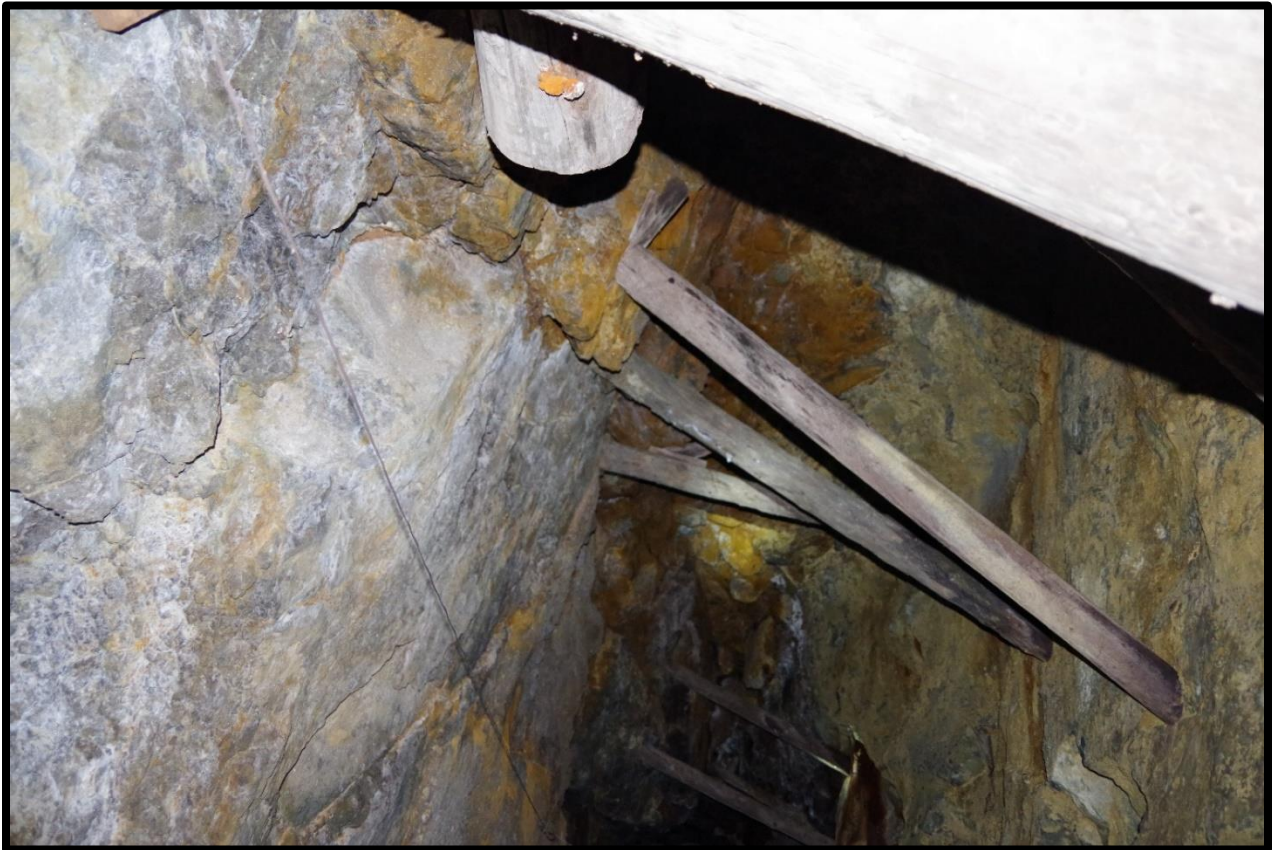
Photo 35: Typical timber stulls; Note hanging wall, Amethyst vein, and foot wall

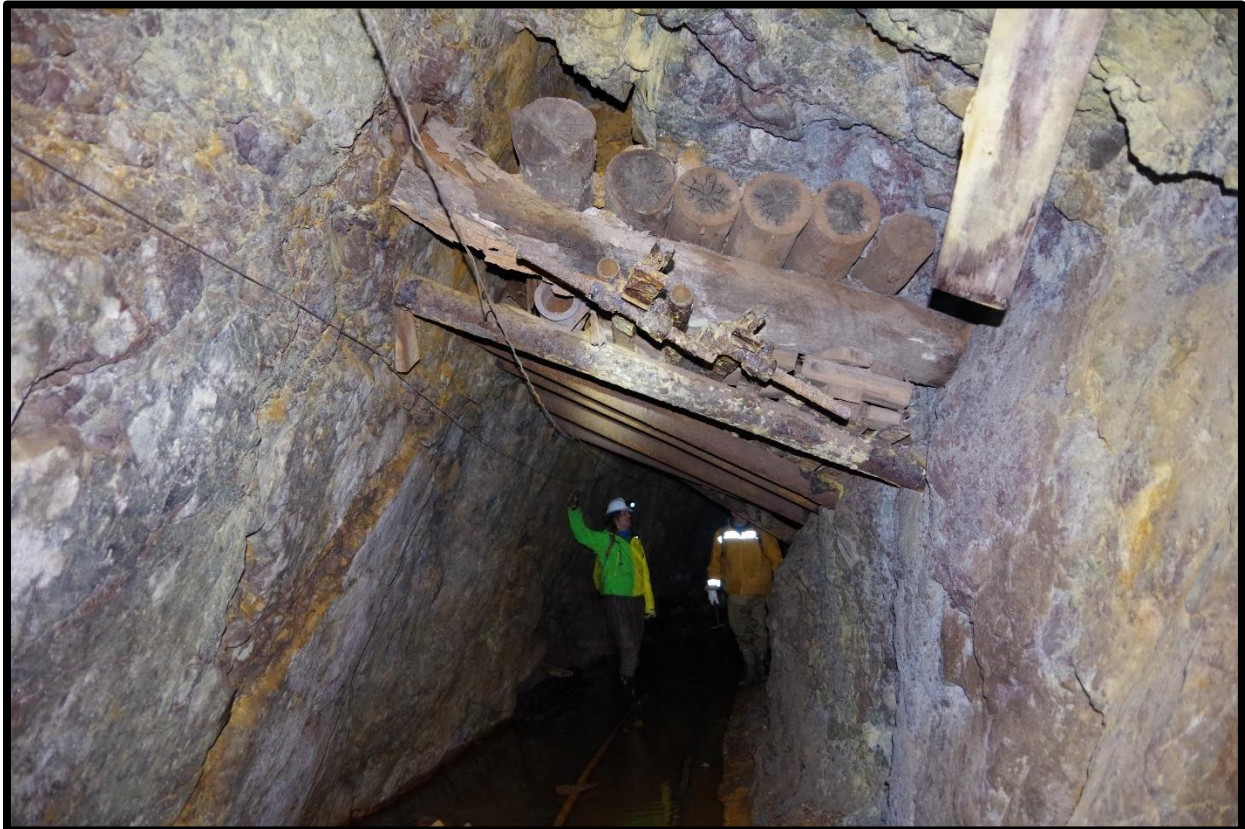
**Photo 39: Steel pipe stulls near 32+20; Note pipe cribbing**

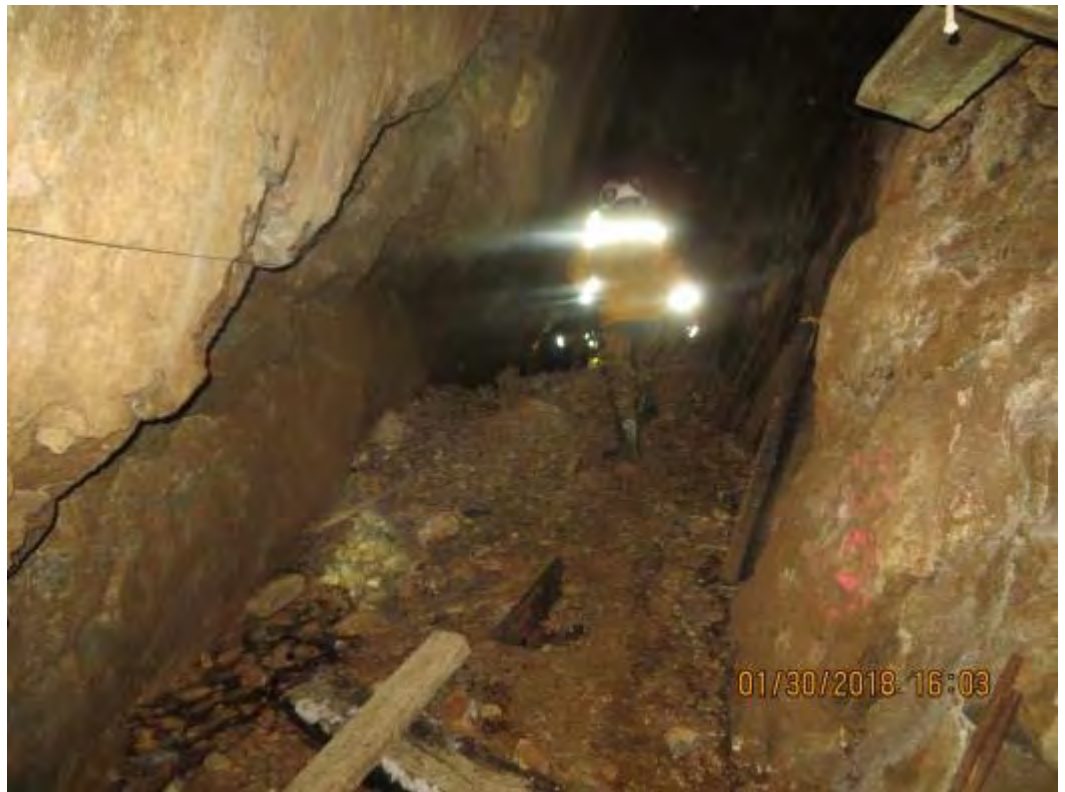
<b>Photo No.</b> <b>17</b>	<b>Date:</b> 01/30/2018
<b>Photo Coordinates</b>	
<b>Lat</b>	--
<b>Long</b>	--
<b>Direction Photo Taken:</b> <b>Northeast</b>	
<b>Description:</b>  In tunnel roof fall at the 44 Raise. This fall is acting as a coffer dam and is holding back water. If this were be removed the water would flow outby to the Daylight Winze, and back into the Nelson Tunnel.

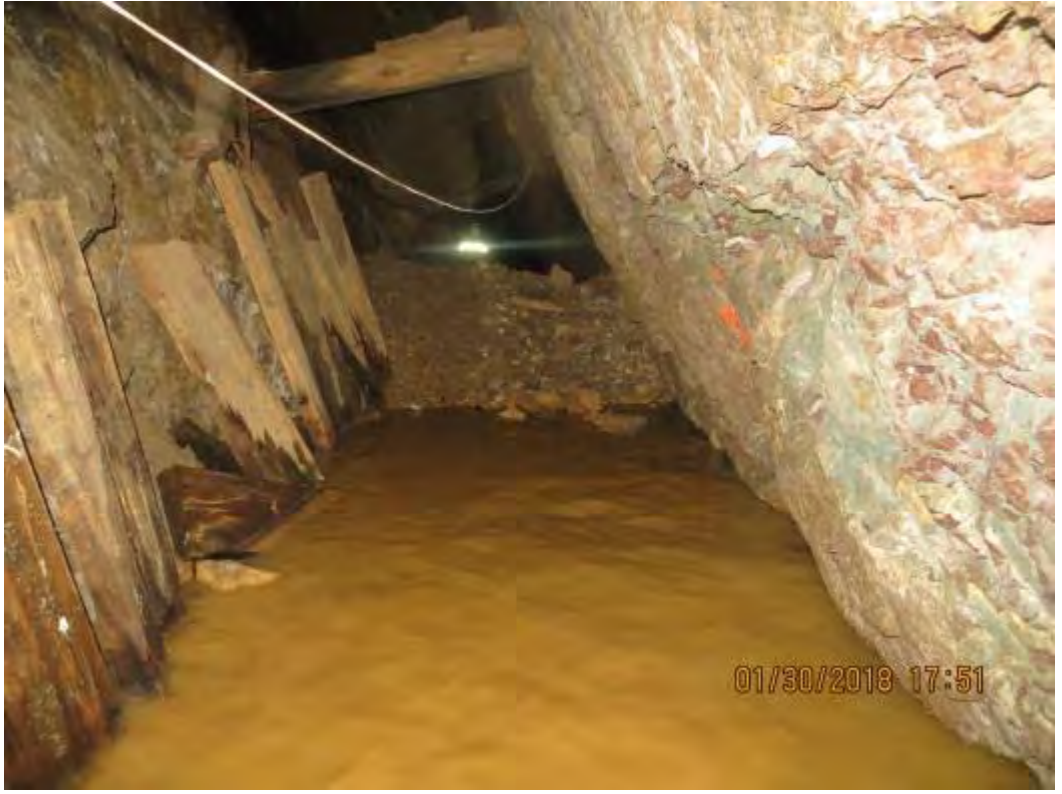
<table border="1"> <tr> <td><b>Photo No.</b> <b>19</b></td><td><b>Date:</b> 01/31/2018</td></tr> <tr> <td colspan="2"><b>Photo Coordinates</b></td></tr> <tr> <td><b>Lat</b></td><td>--</td></tr> <tr> <td><b>Long</b></td><td>--</td></tr> <tr> <td colspan="2"><b>Direction Photo Taken:</b> <b>Southeast</b></td></tr> <tr> <td colspan="2"> <b>Description:</b>             Looking outby at the roof fall at the 44 Raise. Note the water built up behind the roof fall.         </td></tr> </table>	<b>Photo No.</b> <b>19</b>	<b>Date:</b> 01/31/2018	<b>Photo Coordinates</b>		<b>Lat</b>	--	<b>Long</b>	--	<b>Direction Photo Taken:</b> <b>Southeast</b>		<b>Description:</b>  Looking outby at the roof fall at the 44 Raise. Note the water built up behind the roof fall.

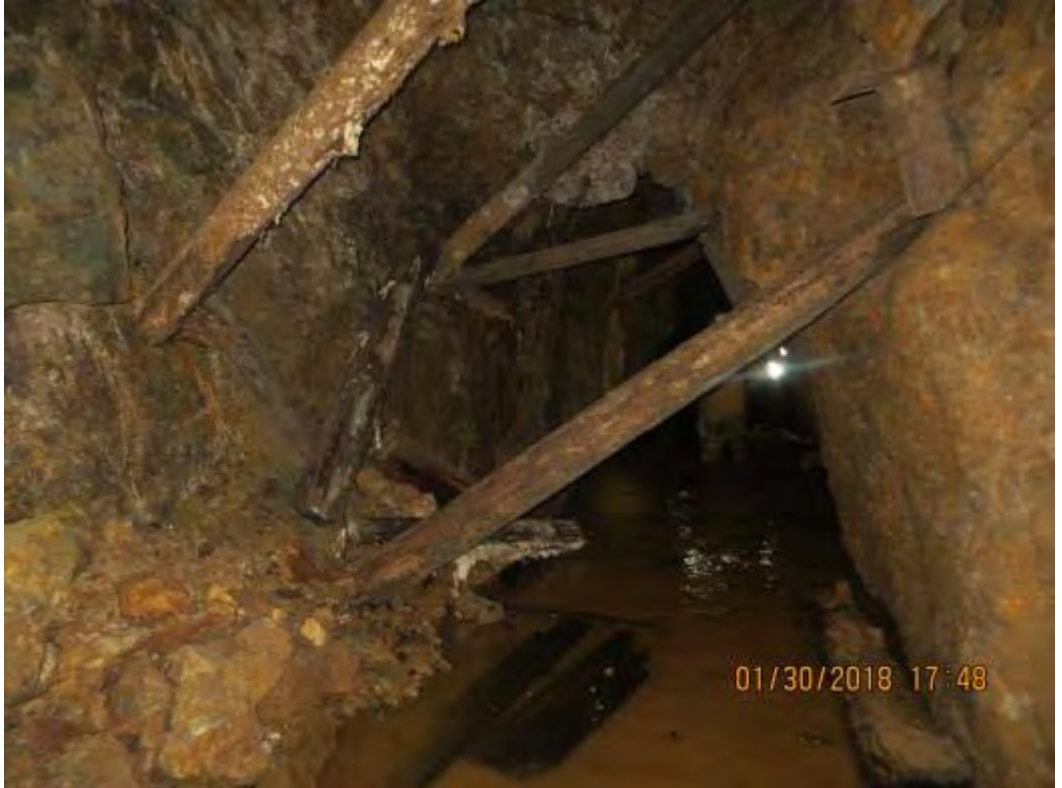
<b>Photo No.</b> <b>20</b>	<b>Date:</b> 01/30/2018												
<b>Photo Coordinates</b>													
<b>Lat</b>	--												
<b>Long</b>	--												
<b>Direction Photo Taken:</b> <b>Southeast</b>													
<b>Description:</b>  Area inby the 44 Raise where stope timbers and roof fall have occurred.

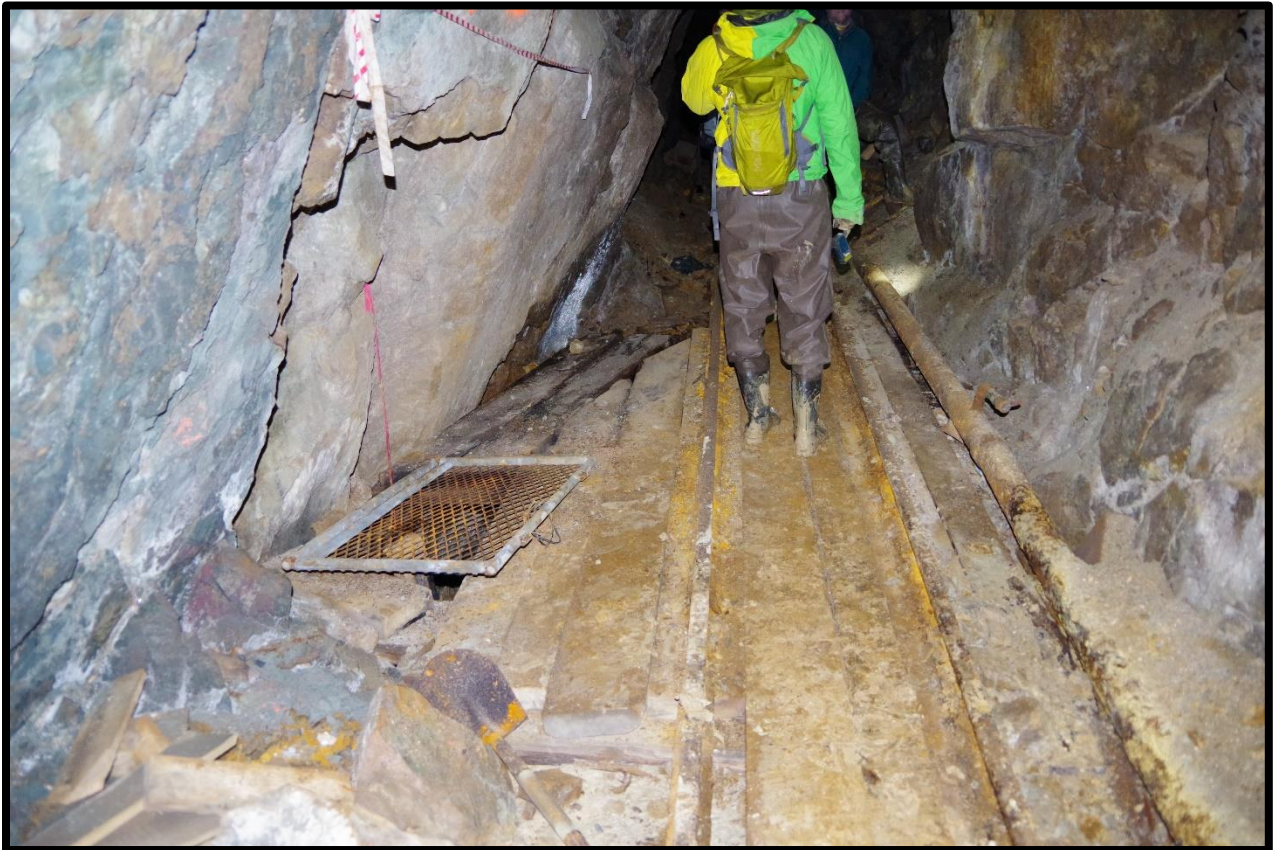
Photo 53: No Name/Y02 Winze 44+60

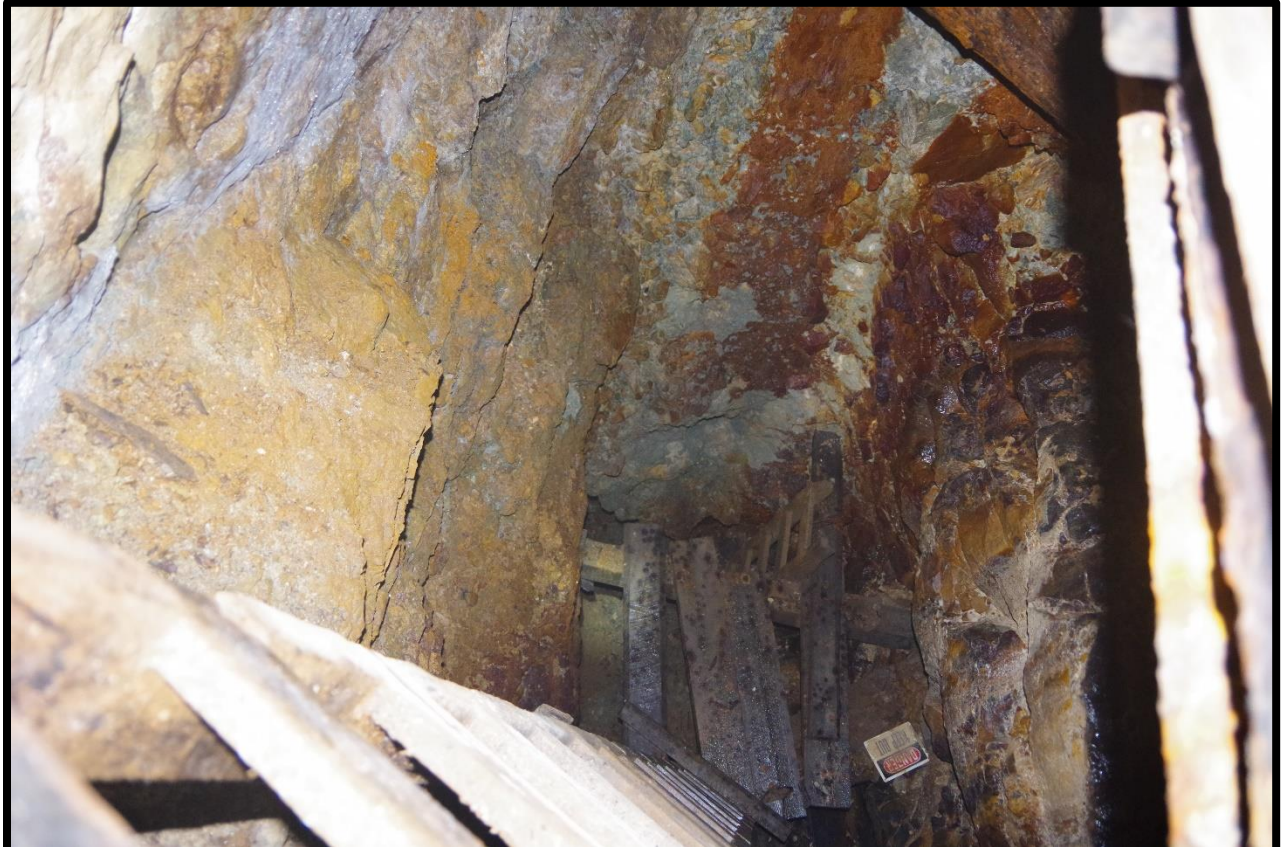
Photo 54: Looking down No Name/y02 Winze

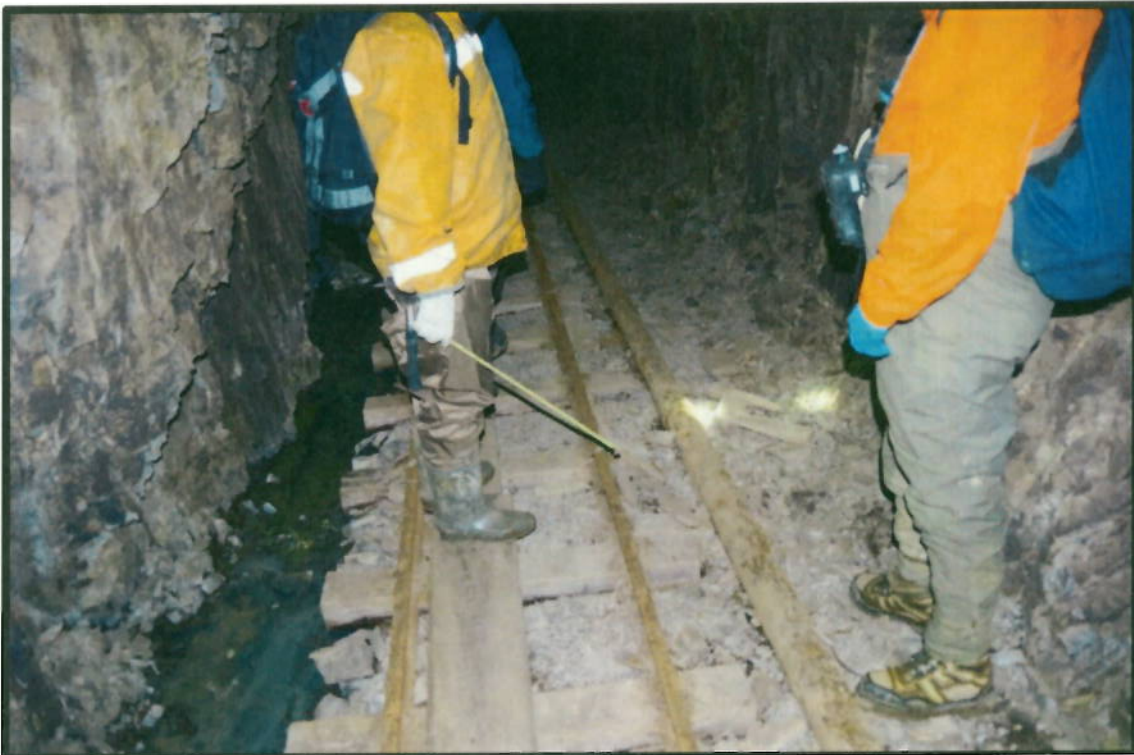
**Photo 8: Typical rail, ditch, and invert in Commodore 5 Cross Cut**

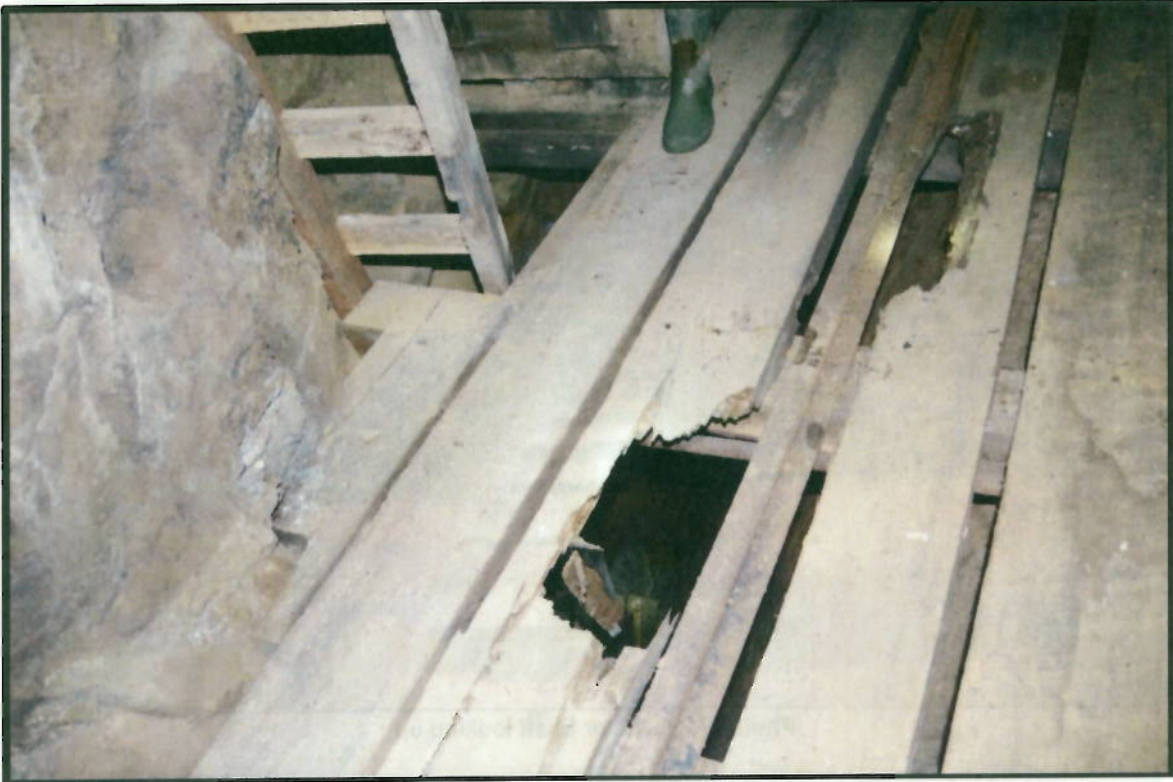
Photo 17: Daylight Winze with rotten wood cover

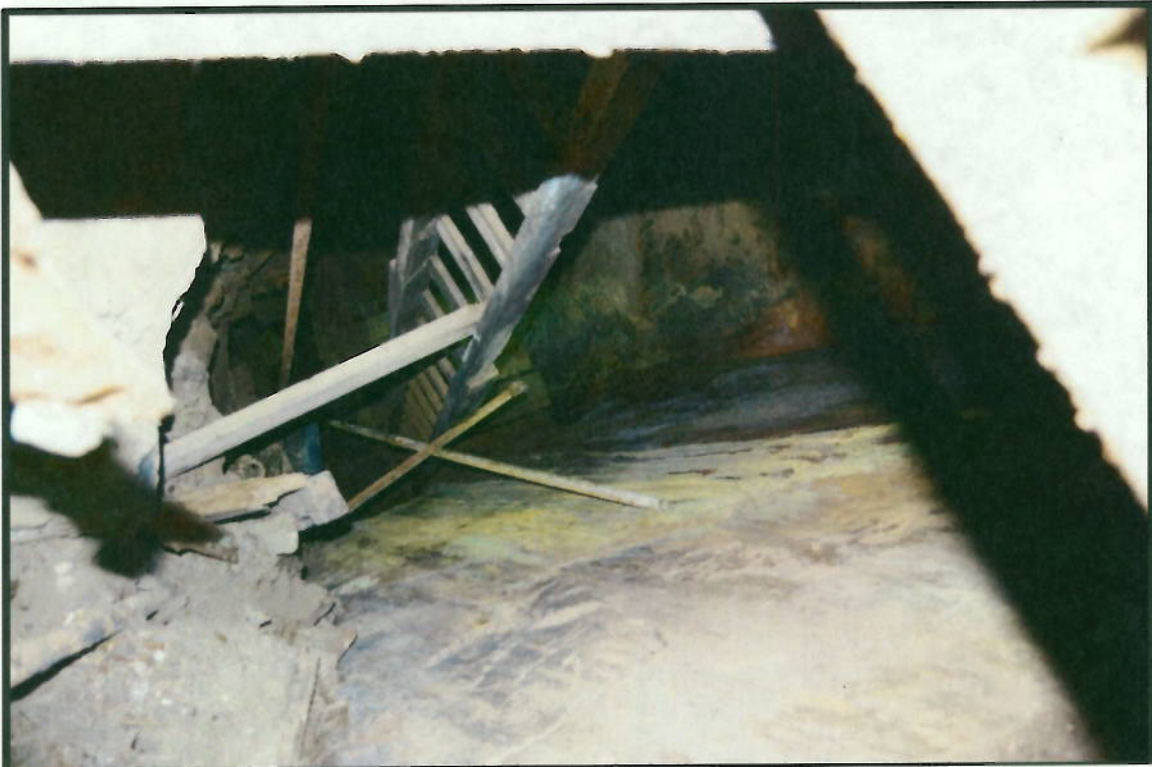
Photo 18: Looking down Daylight Winze: Note smooth footwall, ladder, and landing

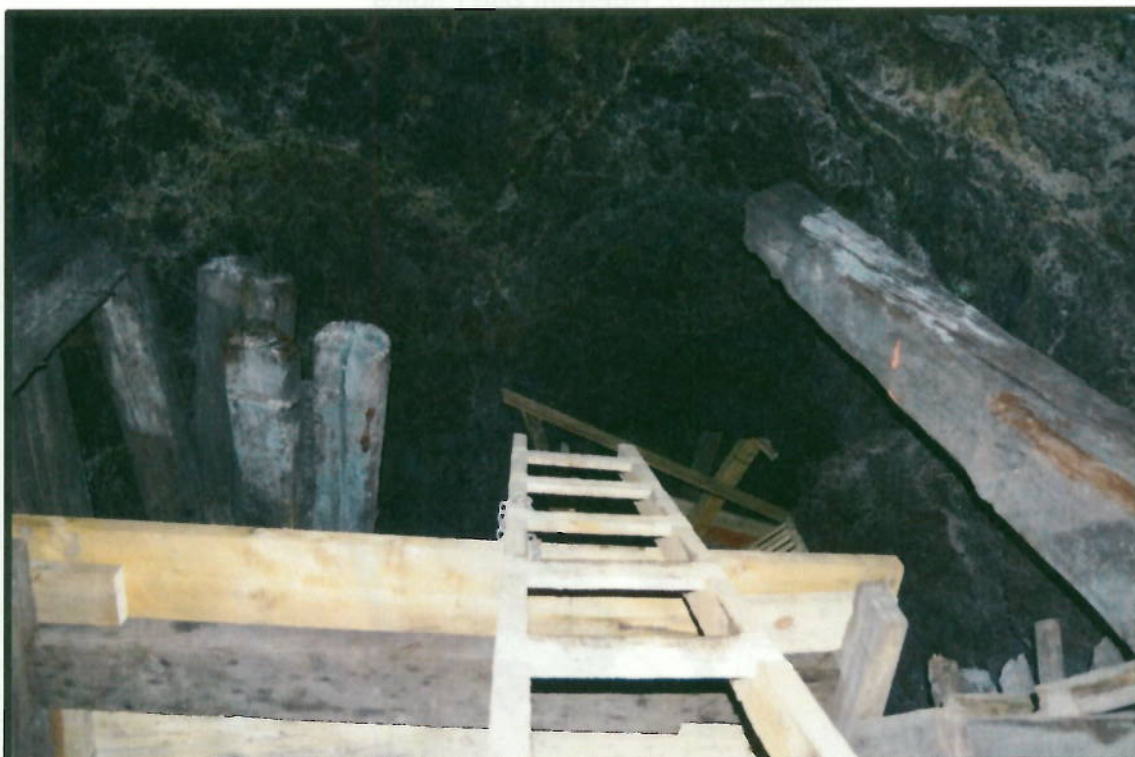
Photo 27: Bachelor Shaft looking up

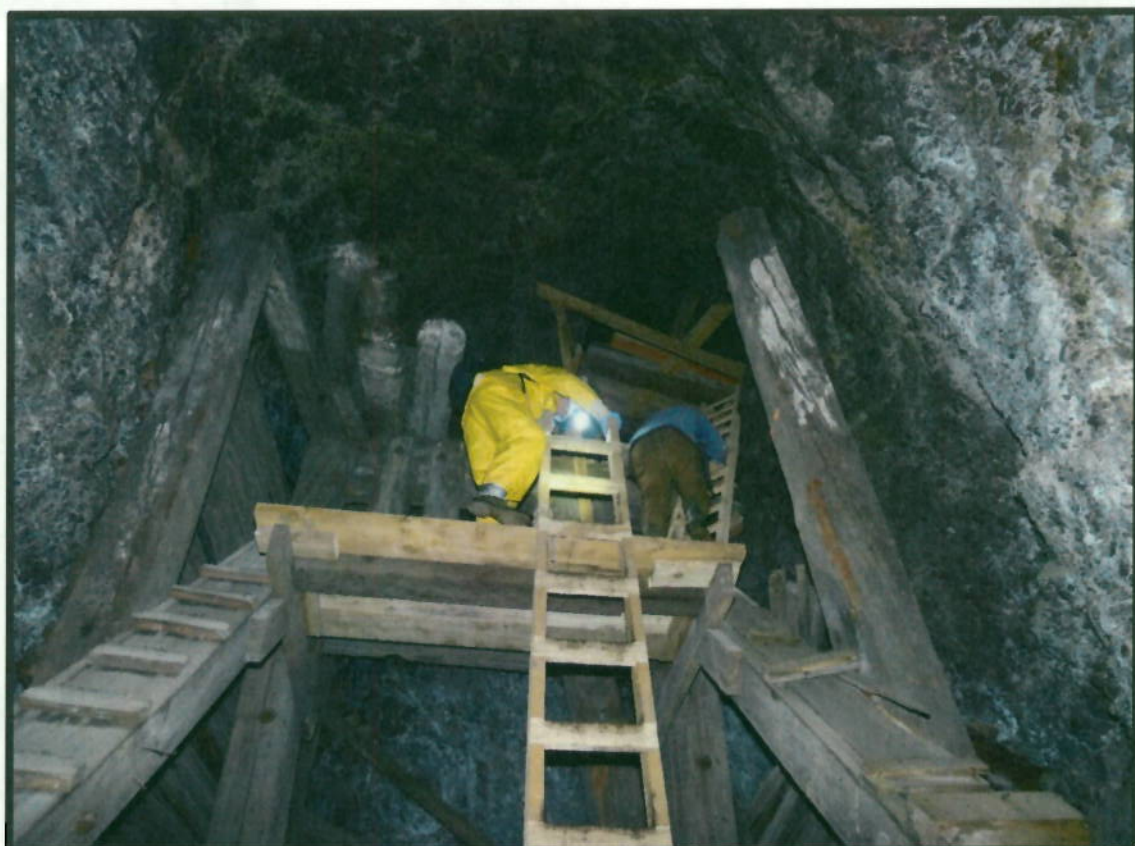
Photo 28: : Bachelor Shaft looking up to second landing

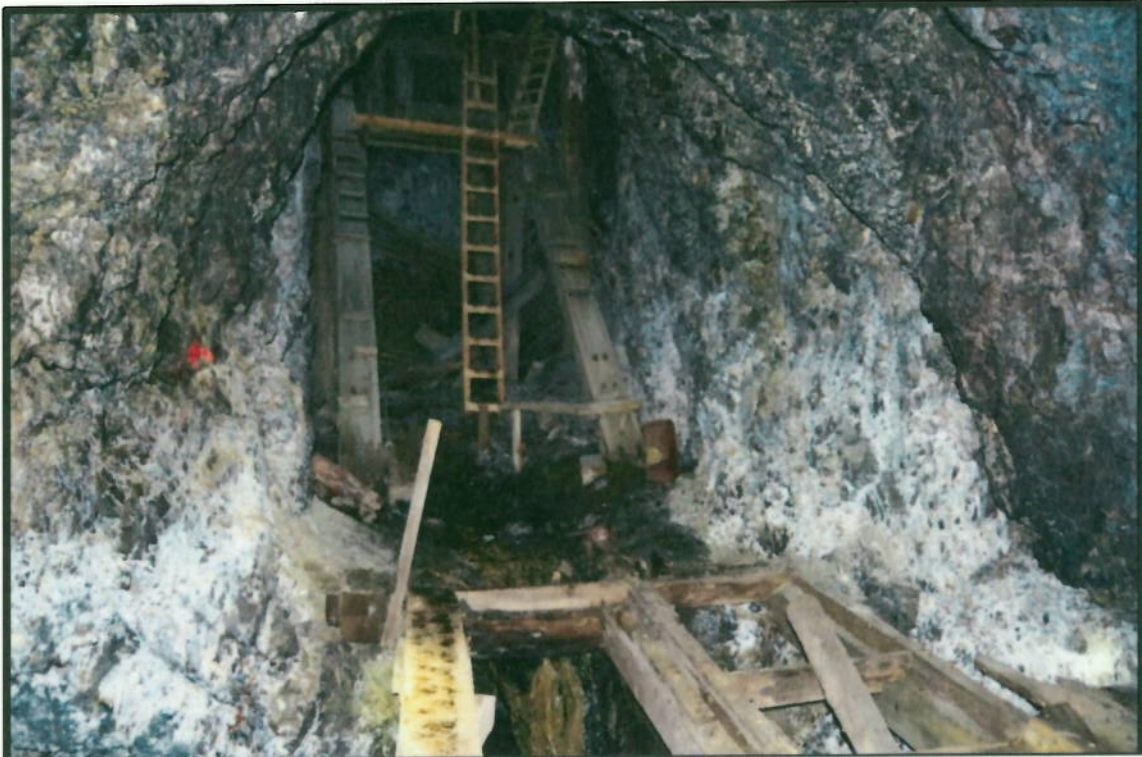
Photo 29: Bachelor Shaft bottom and second landing seen from far side of Nelson Tunnel

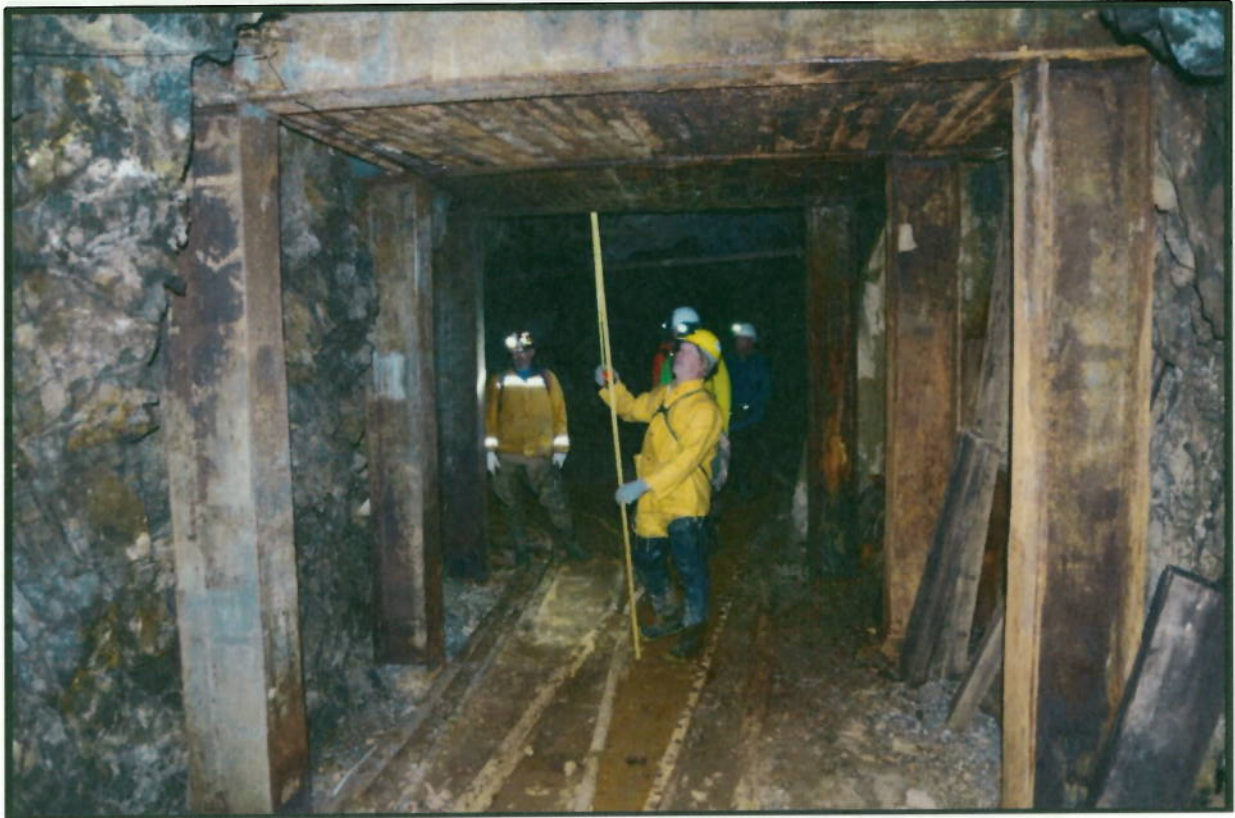
Photo 33: Measuring Archimedes Raise dimensions 26+64

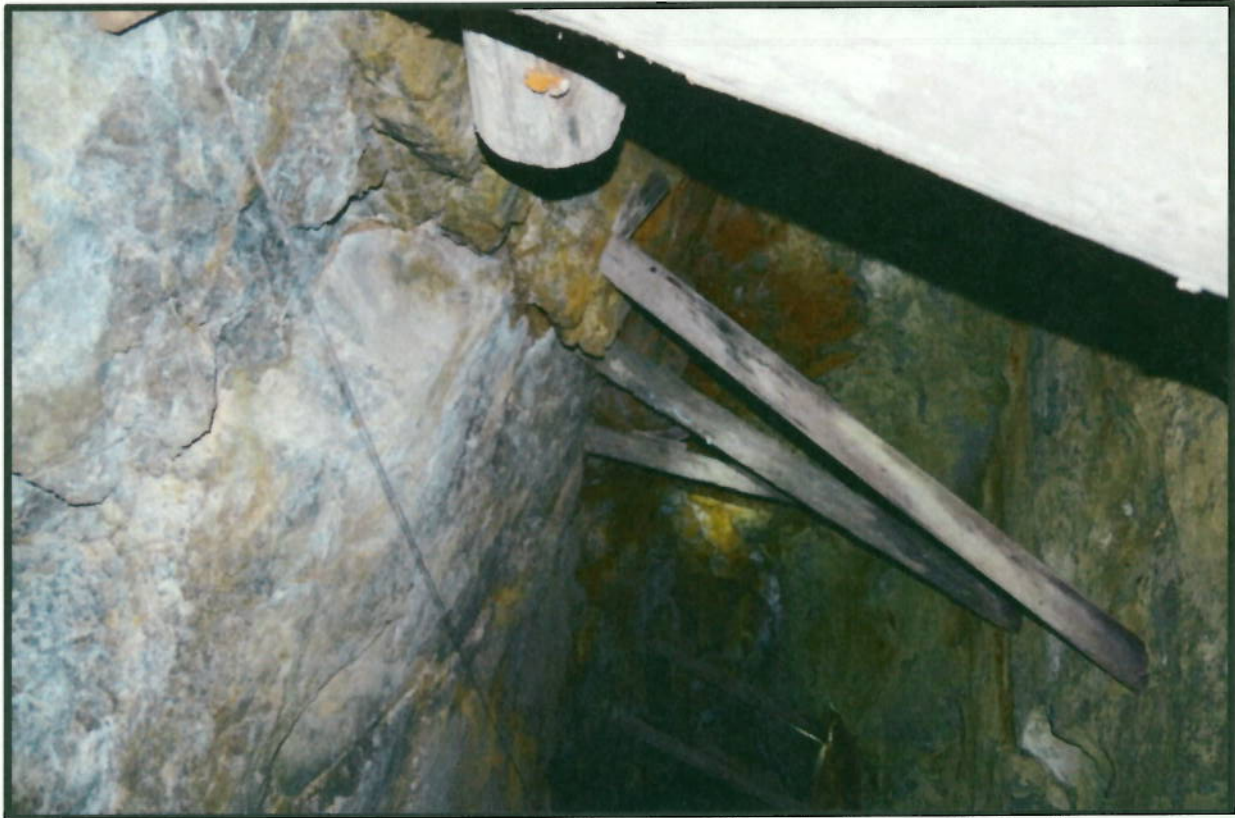
Photo 35: Typical timber stulls; Note hanging wall, Amethyst vein, and foot wall

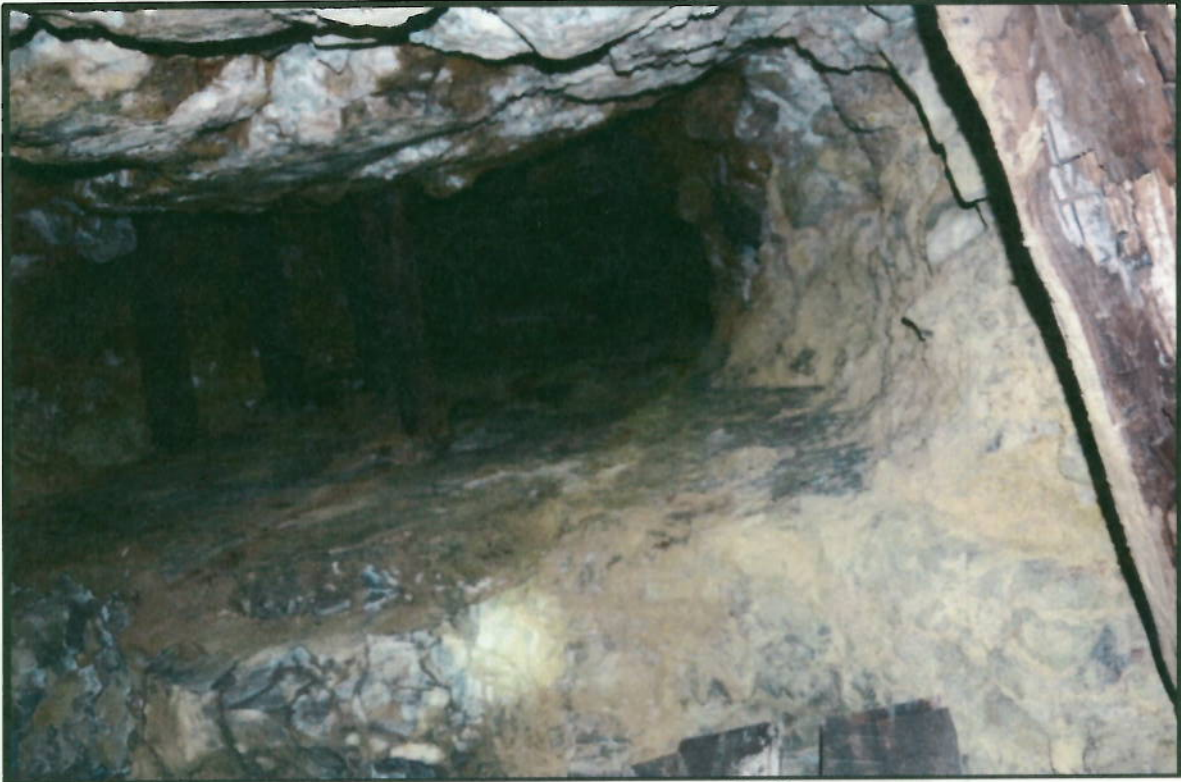
Photo 37: Looking up raise at 30+20

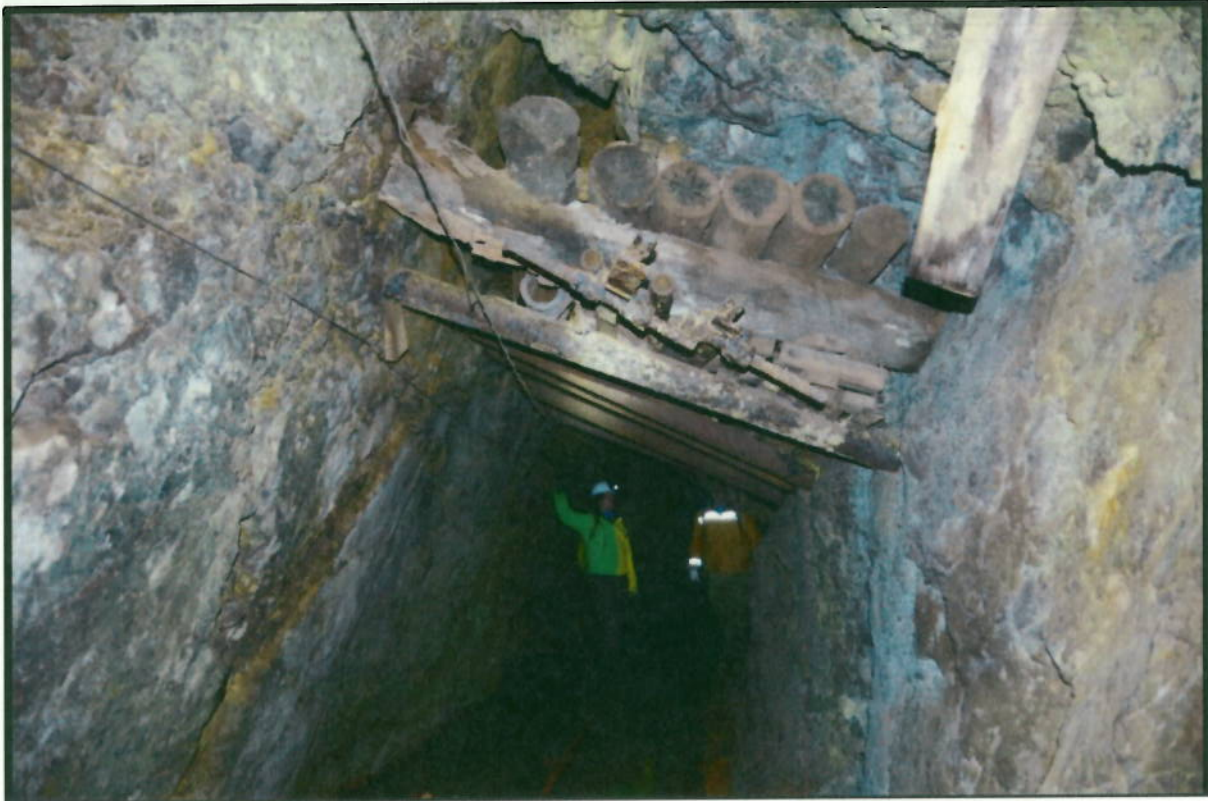
Photo 39: Steel pipe stulls near 32+20; Note pipe cribbing

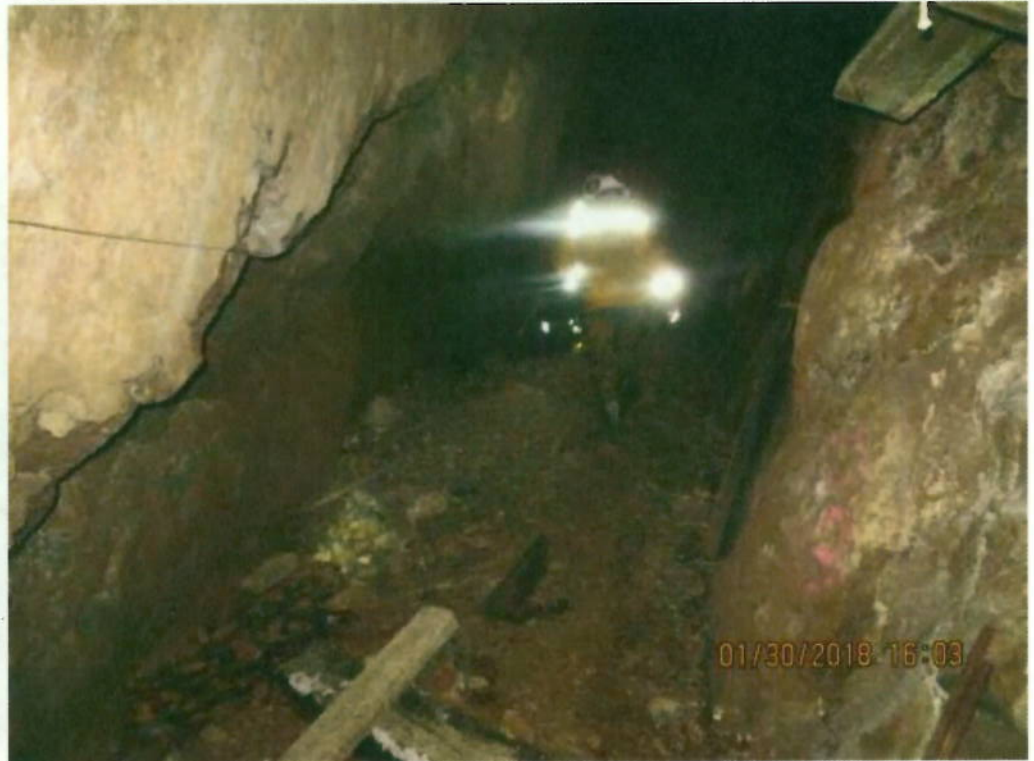
In tunnel roof fall at the 44 Raise. This fall is acting as a coffer dam and is holding back water. If this were be removed the water would flow outby to the Daylight Winze, and back into the Nelson Tunnel.
