**ACTION MEMORANDUM AMENDMENT 2**

**SUBJECT:** Request for a Ceiling and Scope Increase and Continued Exemption from the 12-month and \$2 million Statutory Limits for Removal Action at the Nelson Tunnel/Commodore Waste Rock Site in Mineral County, Colorado

Site ID# 08MB

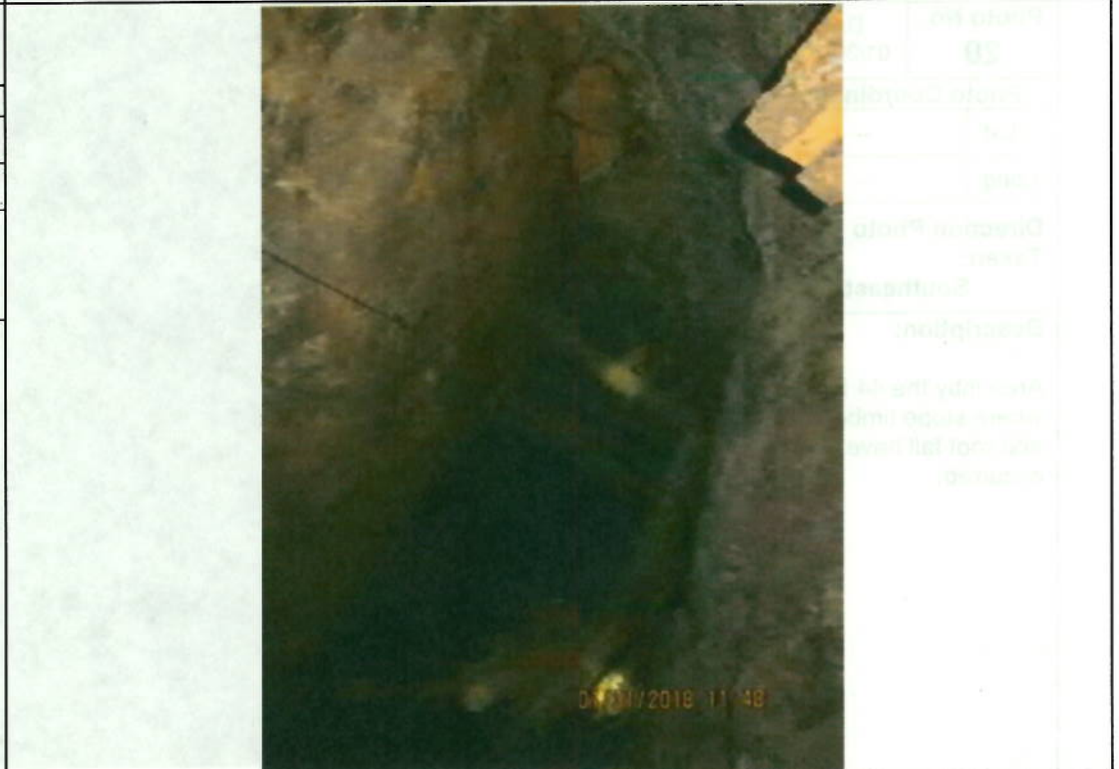
**Photo No.**  
**18**

Looking up the 44 Raise.

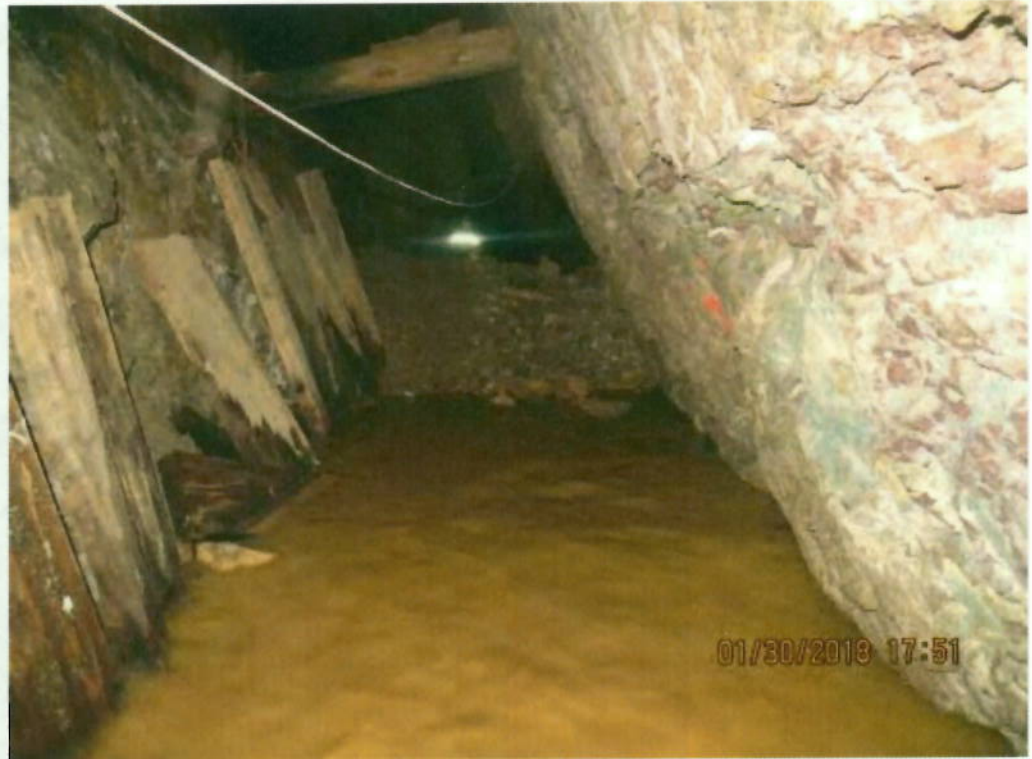
Looking outby at the roof fall at the 44 Raise. Note the water built up behind the roof fall.

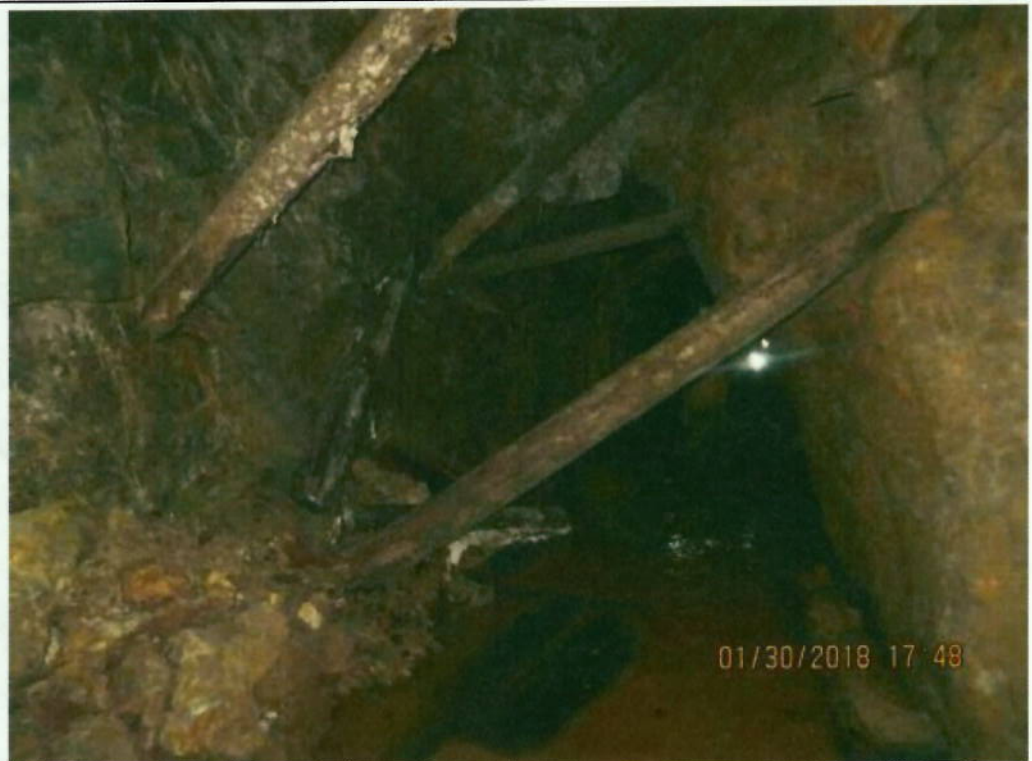
**Photo No.**  
**20**

Area inby the 44 Raise where stope timbers and roof fall have occurred.
