INSPECTION REPORT

STREET: GRAND AVE.	MAP #1:	MH: NN9-02
CITY: ST LOUIS, MO.	MAP #2:	MH: NN5-01
LOCALE: private property	TAPE #: EMA-1	TV'D LGTH: 83.1 ft

INSPECT REASON: gen. condition	PIPE SIZE: 10"
SECTION TYPE: combined wastewater ?	MATERIAL: cast iron JT LGTH:
AREA:	LINING:
	RSRVD:

REMARK: CARTER CARBURETOR SITE

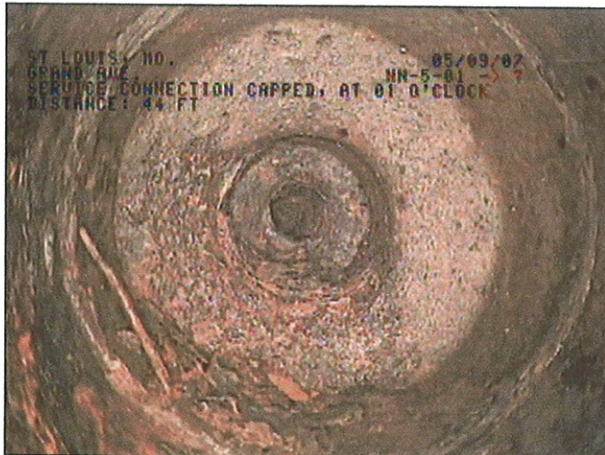
IMAGE: 9a, TAPE #: EMA-1, 00:10:00
44FT, service connection capped, at 01 o'clock

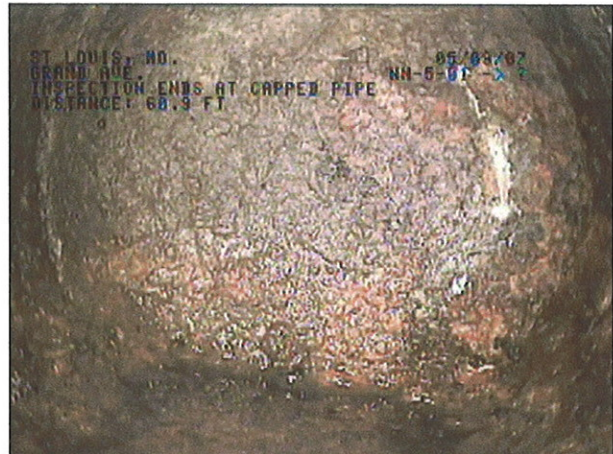
IMAGE: 12a, TAPE #: EMA-1, 00:11:43
60.9FT, inspection ends at capped pipe

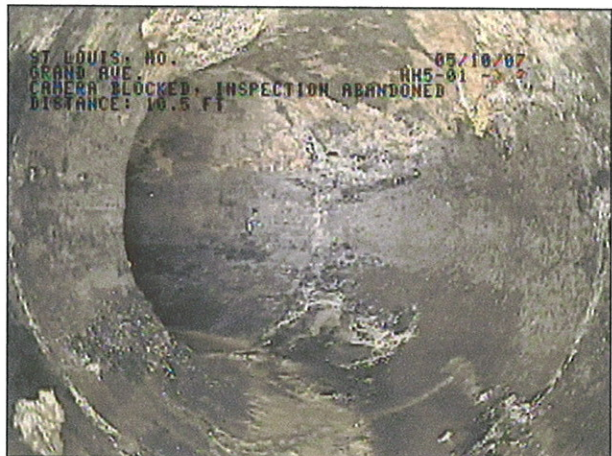
IMAGE: 25a, TAPE #: EMA-1, 00:29:11
10.5FT, camera blocked, inspection abandoned

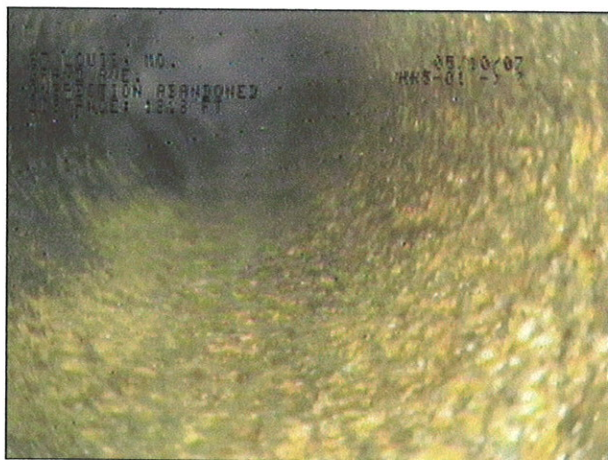
IMAGE: 28a, TAPE #: EMA-1, 00:34:07
13.8FT, inspection abandoned

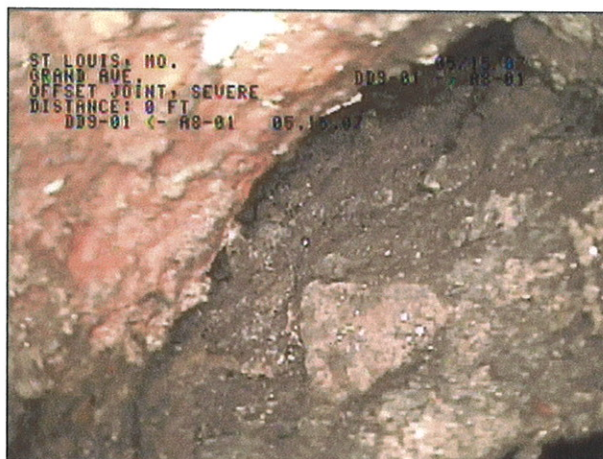
IMAGE: 30a, TAPE #: EMA-1, 00:36:12
2.5FT, offset joint, severe

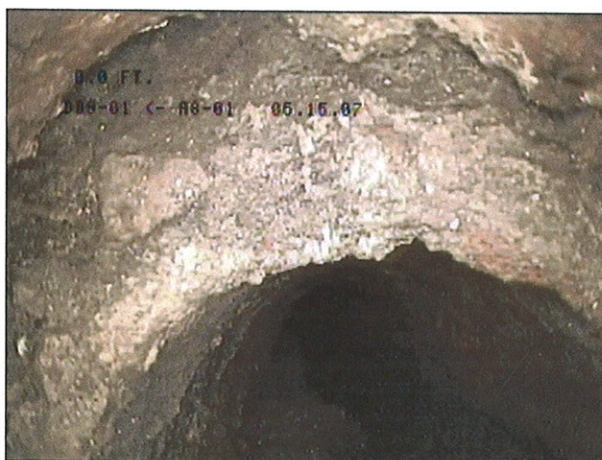
IMAGE: 31a, TAPE #: EMA-1, 00:36:31
2.5FT, inspection abandoned

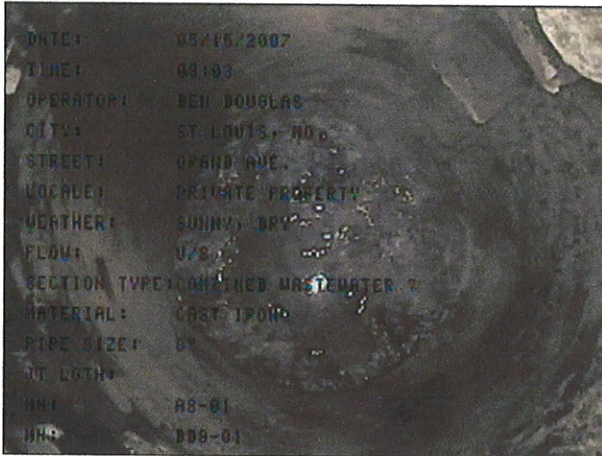
IMAGE: 32a, TAPE #: EMA-1, 00:36:56
6.3FT, inspection begins at downstream manhole

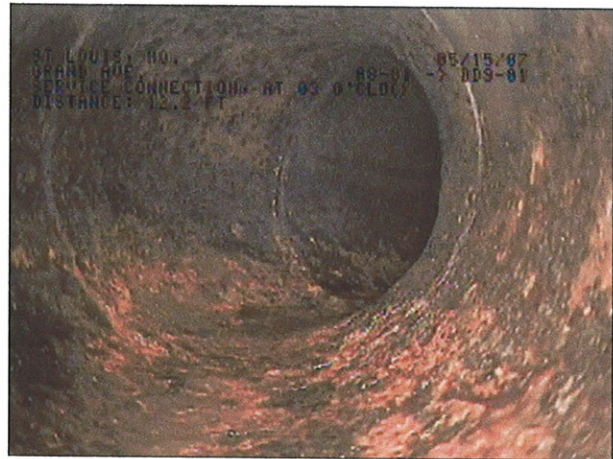
IMAGE: 33a, TAPE #: EMA-1, 00:40:04
12.2FT, service connection, at 03 o'clock

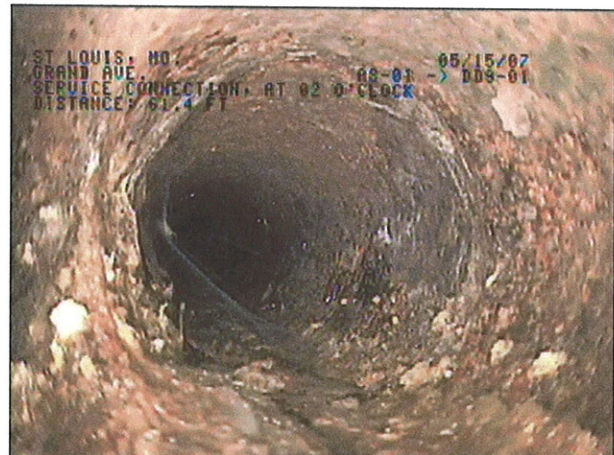
IMAGE: 35a, TAPE #: EMA-1, 00:41:36
61.4FT, service connection, at 02 o'clock

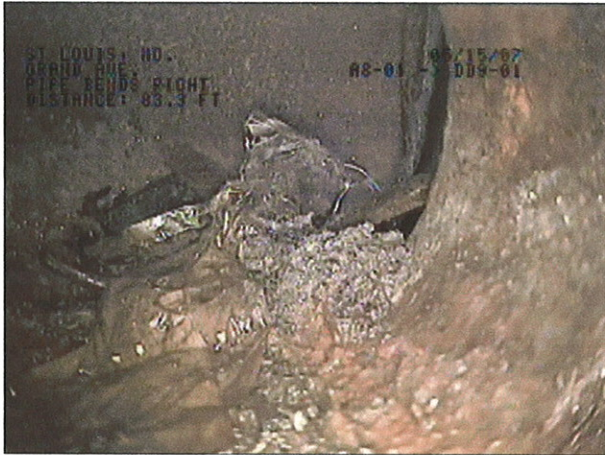
IMAGE: 36a, TAPE #: EMA-1, 00:42:40
83.3FT, pipe bends right

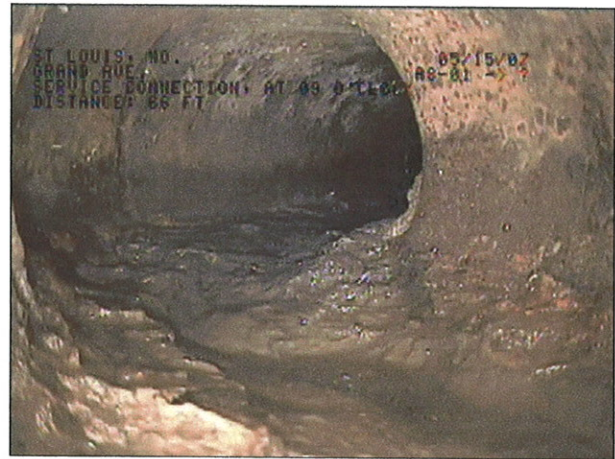
IMAGE: 39a, TAPE #: EMA-1, 00:47:54
66FT, service connection, at 09 o'clock

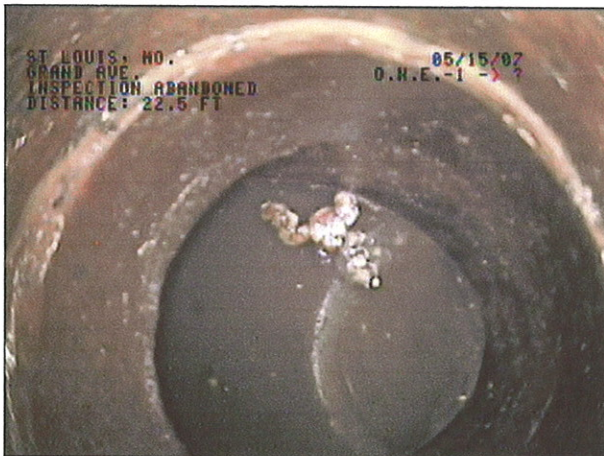
IMAGE: 46a, TAPE #: EMA-1, 00:55:20
22.5FT, inspection abandoned

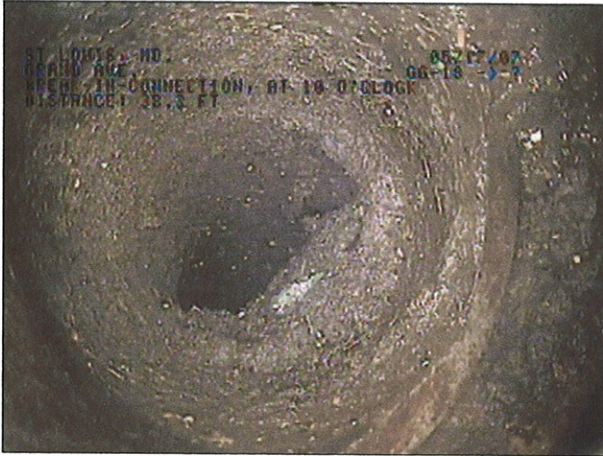
IMAGE: 50a, TAPE #: EMA-1, 00:59:53
38.3FT, break-in-connection, at 10 o'clock

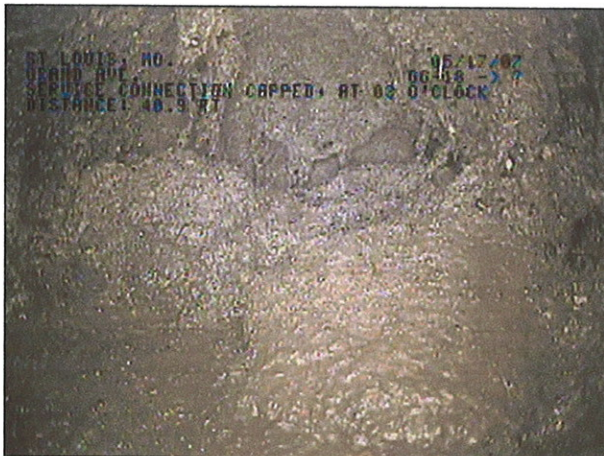
IMAGE: 51a, TAPE #: EMA-1, 01:00:26
40.9FT, service connection capped, at 03 o'clock

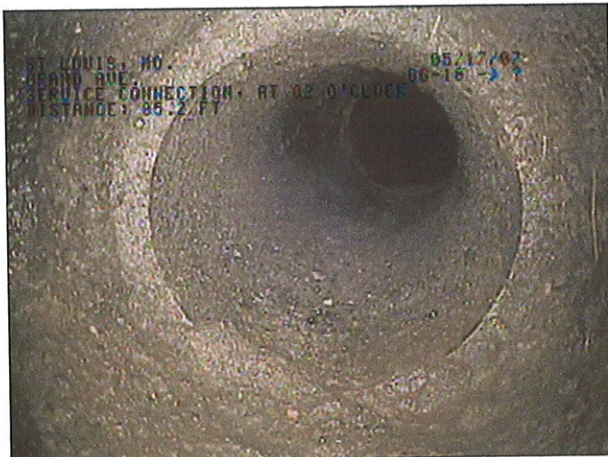
IMAGE: 55a, TAPE #: EMA-1, 01:02:26
85.2FT, service connection, at 02 o'clock

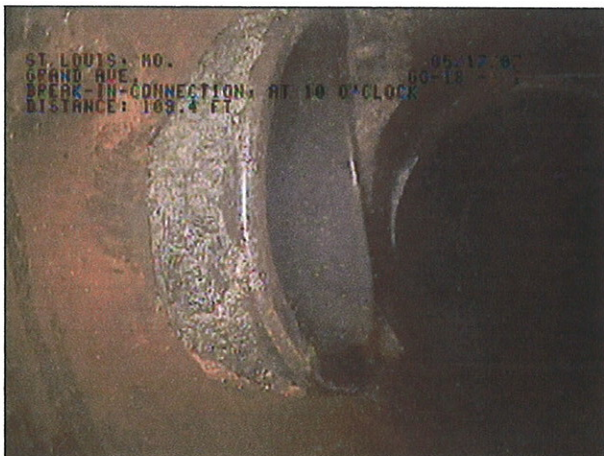
IMAGE: 58b, TAPE #: EMA-1, 01:03:44
109.4FT, break-in-connection, at 10 o'clock

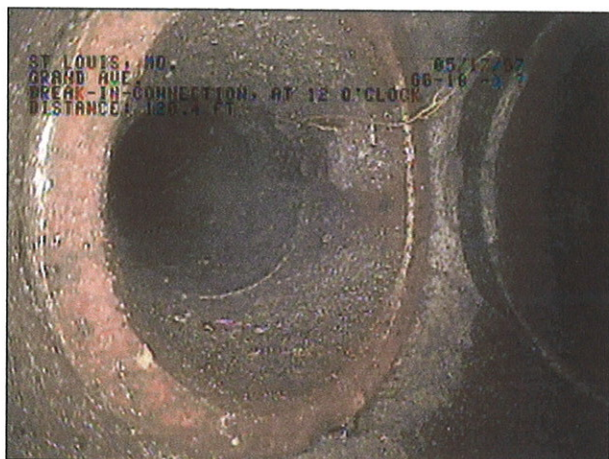
IMAGE: 59b, TAPE #: EMA-1, 01:04:37
120.4FT, break-in-connection, at 12 o'clock

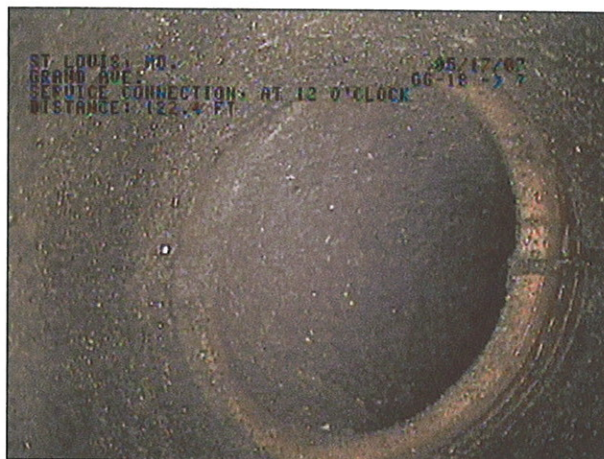
IMAGE: 60a, TAPE #: EMA-1, 01:05:07
122.4FT, service connection, at 12 o'clock

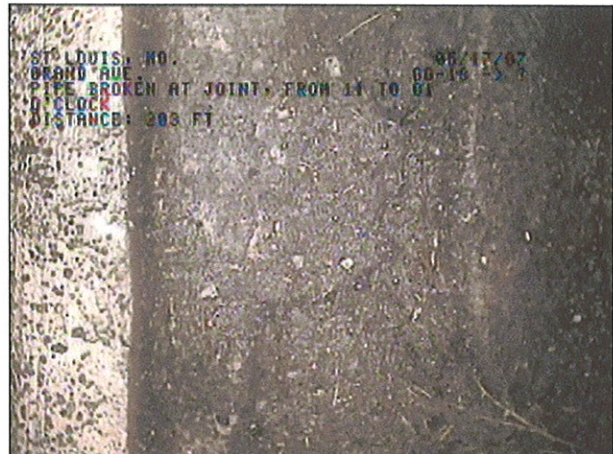
1:462	POSITION	CODE	OBSERVATION	VCR #	PH	RATE
	203.00	500	pipe broken at joint, from 11 to 01 o'clock	01:09:36	69a	3
	204.10	160	break-in-connection, at 12 o'clock	01:09:49	70a, b	1

IMAGE: 69a, TAPE #: EMA-1, 01:09:36
203FT, pipe broken at joint, from 11 to 01 o'clock

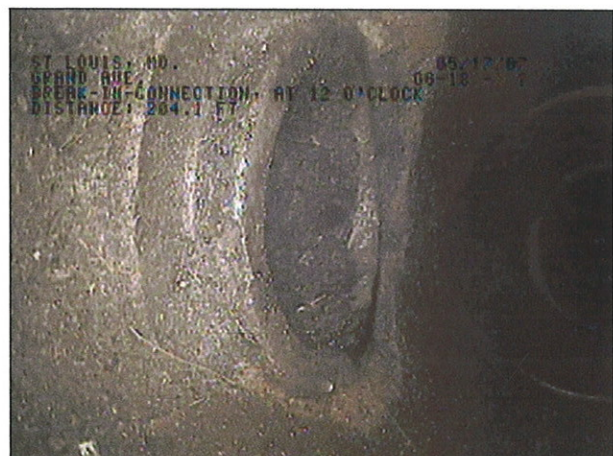
IMAGE: 70b, TAPE #: EMA-1, 01:09:49
204.1FT, break-in-connection, at 12 o'clock

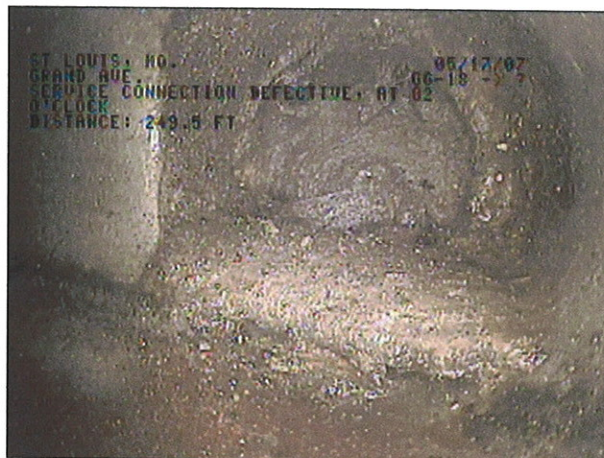
IMAGE: 75a, TAPE #: EMA-1, 01:12:15
249.4FT, service connection defective, at 02 o'clock

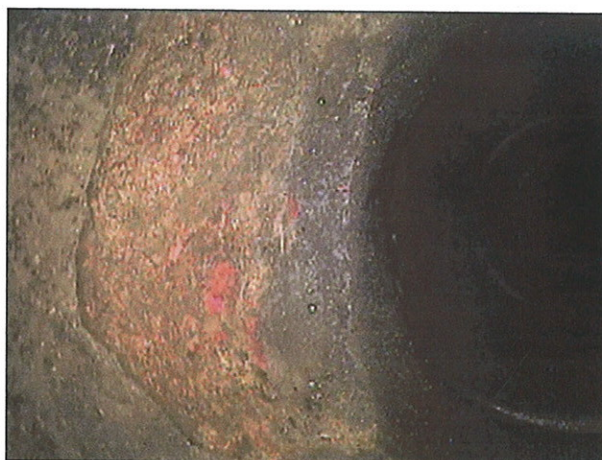
IMAGE: 79b, TAPE #: EMA-1, 01:14:34
286.4FT, Hole in pipe from 11 to 01 o'clock, REMARK:
PATCHED

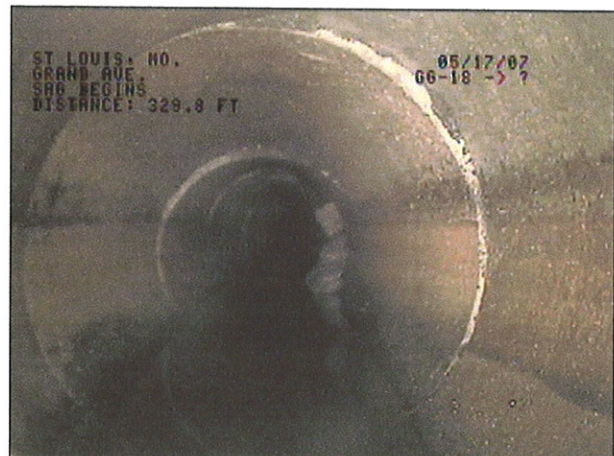
IMAGE: 82a, TAPE #: EMA-1, 01:16:35
329.8FT, sag begins

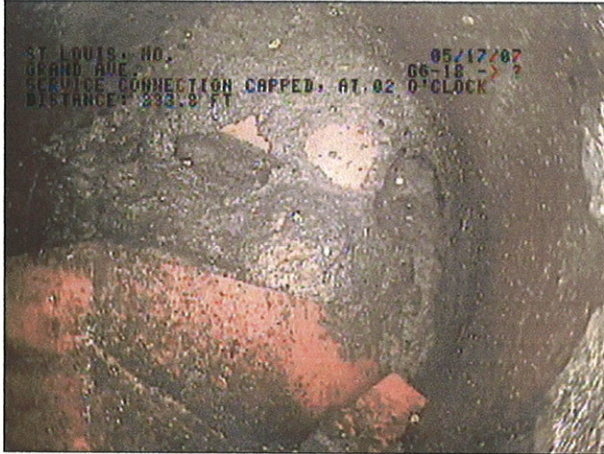
IMAGE: 83a, TAPE #: EMA-1, 01:16:51
333.8FT, service connection capped, at 02 o'clock

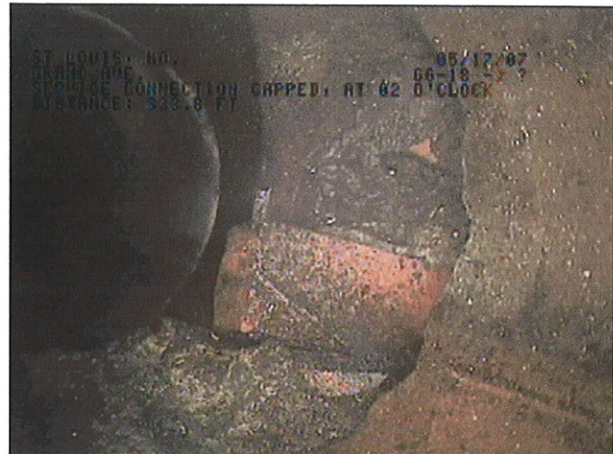
IMAGE: 83b, TAPE #: EMA-1, 01:16:51
333.8FT, service connection capped, at 02 o'clock

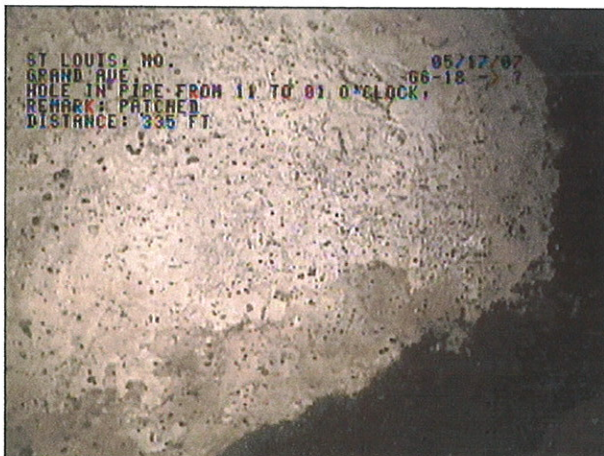
IMAGE: 84a, TAPE #: EMA-1, 01:17:21
335FT, Hole in pipe from 11 to 01 o'clock, REMARK: PATCHED

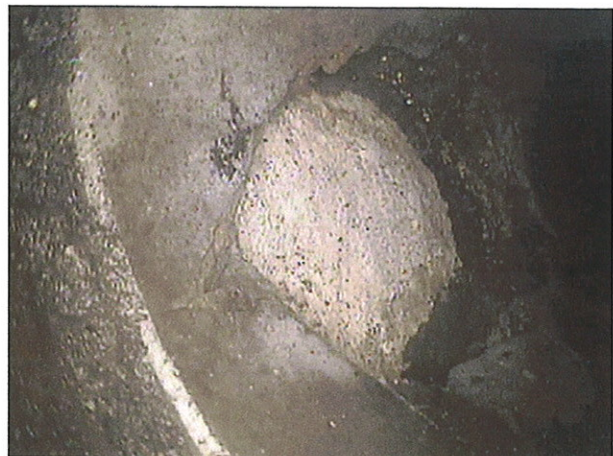
IMAGE: 84b, TAPE #: EMA-1, 01:17:21
335FT, Hole in pipe from 11 to 01 o'clock, REMARK: PATCHED

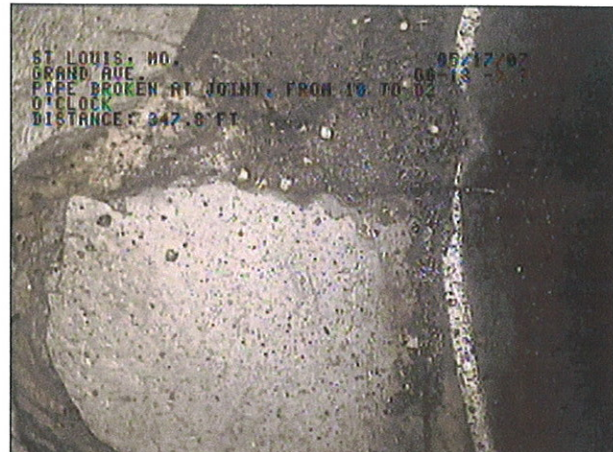
347.80	500	pipe broken at joint, from 10 to 02 o'clock	01:18:19	86a	3
	368.30	160	service connection defective, at 02 o'clock	01:19:05	87a	1
	371.00	0	service connection capped, at 10 o'clock	01:19:19	88a	0

IMAGE: 86a, TAPE #: EMA-1, 01:18:19
347.8FT, pipe broken at joint, from 10 to 02 o'clock

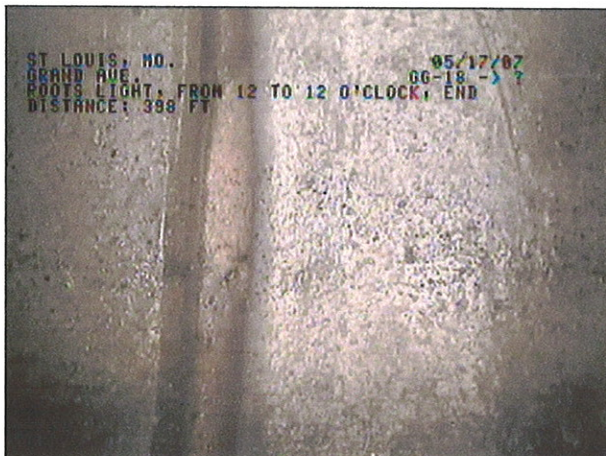
IMAGE: 91a, TAPE #: EMA-1, 01:20:57
398FT, roots light, from 12 to 12 o'clock, END

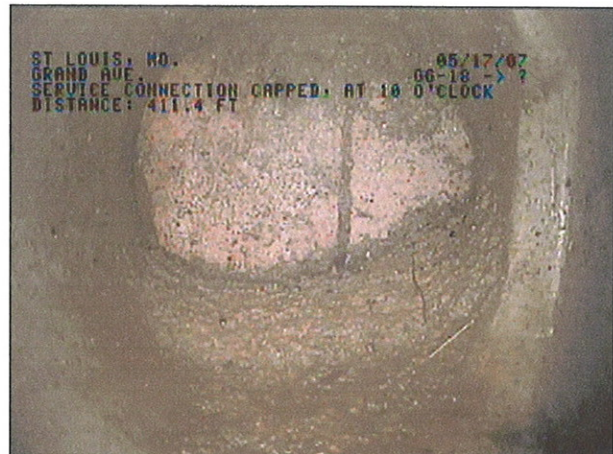
IMAGE: 94a, TAPE #: EMA-1, 01:22:11
411.4FT, service connection capped, at 10 o'clock

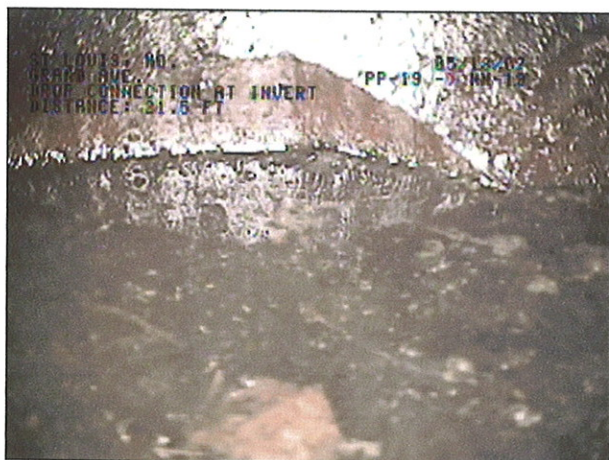
IMAGE: 112a, TAPE #: EMA-1, 01:36:28
21.5FT, drop connection at invert

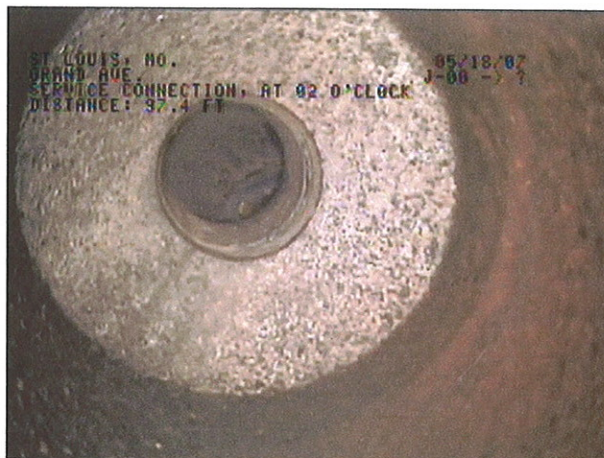
IMAGE: 129a, TAPE #: EMA-1, 01:48:12
97.4FT, service connection, at 02 o'clock

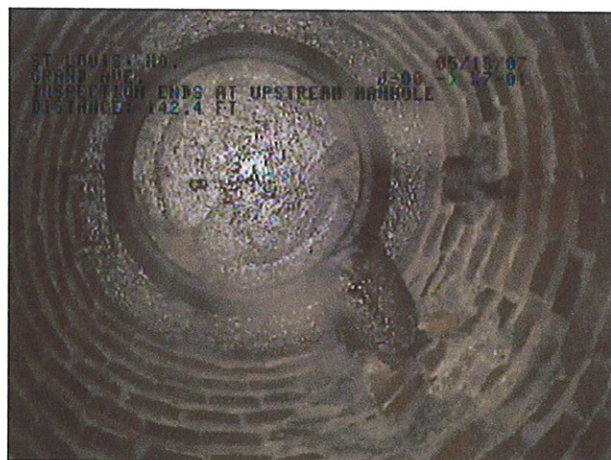
IMAGE: 130a, TAPE #: EMA-1, 01:50:20
142.4FT, inspection ends at upstream manhole

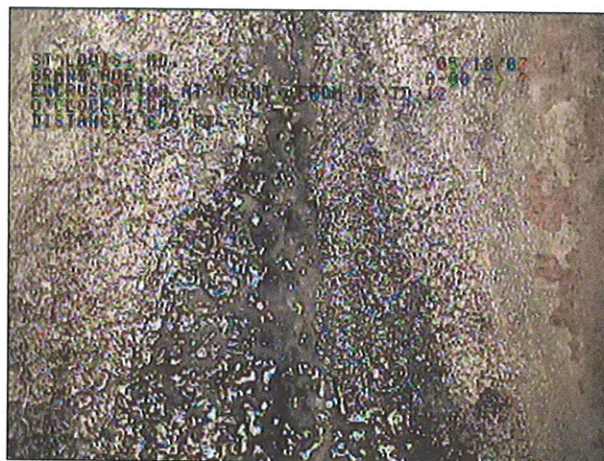
IMAGE: 132a, TAPE #: EMA-1, 01:52:53
6.8FT, encrustation at joint, from 12 to 12 o'clock light, START

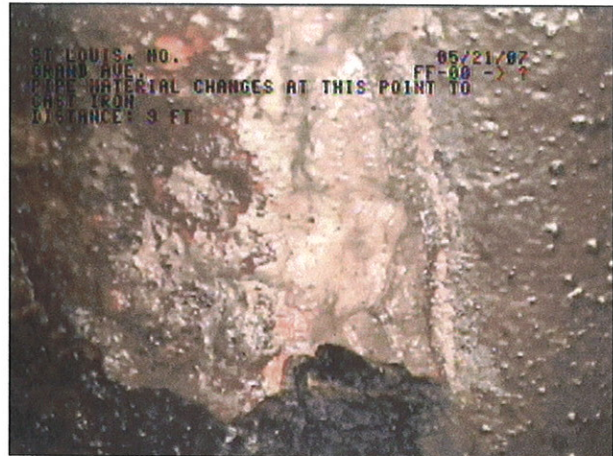
IMAGE: 141a, TAPE #: EMA-1, 02:01:36
9FT, pipe material changes at this point to cast iron

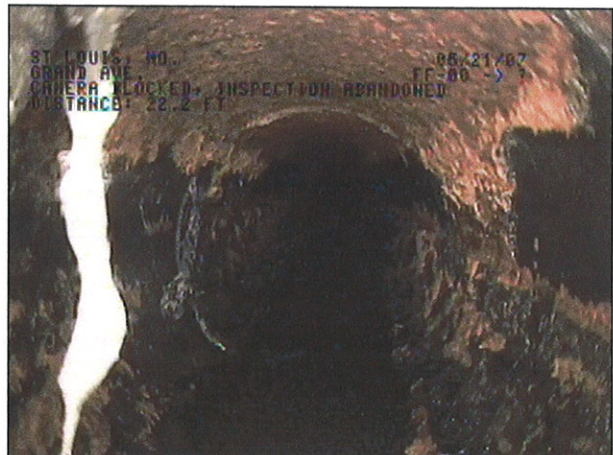
IMAGE: 143a, TAPE #: EMA-1, 02:02:29
22.2FT, camera blocked, inspection abandoned

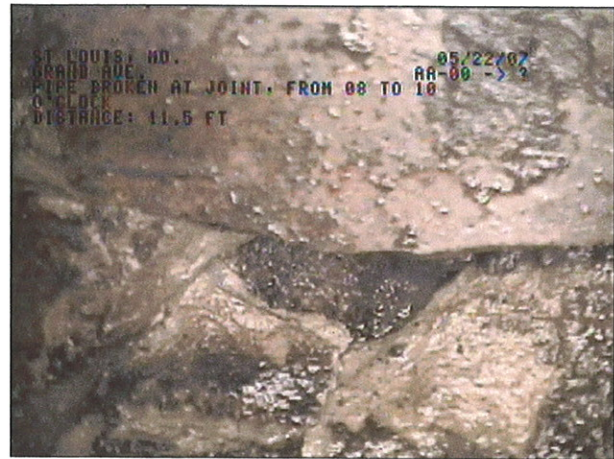
AA-00	0.00	0	inspection begins at downstream manhole	02:02:29	144a	0
	8.80	0	pipe bends right	02:04:53		0
	11.50	500	pipe broken at joint, from 08 to 10 o'clock	02:05:11	146a	3
	17.00	0	pipe bends left	02:05:33		0
	29.00	0	pipe bends right	02:06:15		0
	39.00	160	service connection defective, at 09 o'clock	02:06:38	149a	1
	62.90	250	intruding break-in-connection, at 02 o'clock	02:07:31	150a, b	2
	64.00	250	intruding break-in-connection, at 10 o'clock	02:08:00	151a, b	2
	93.30	0	pipe bends right	02:08:48		0
	97.80	0	pipe bends left	02:08:58		0
	110.70	0	pipe bends right	02:09:17		0
	120.30	0	pipe bends right	02:09:32		0
D6-01	125.40	0	inspection ends at upstream manhole	02:10:22	156a	0

IMAGE: 146a, TAPE #: EMA-1, 02:05:11
11.5FT, pipe broken at joint, from 08 to 10 o'clock

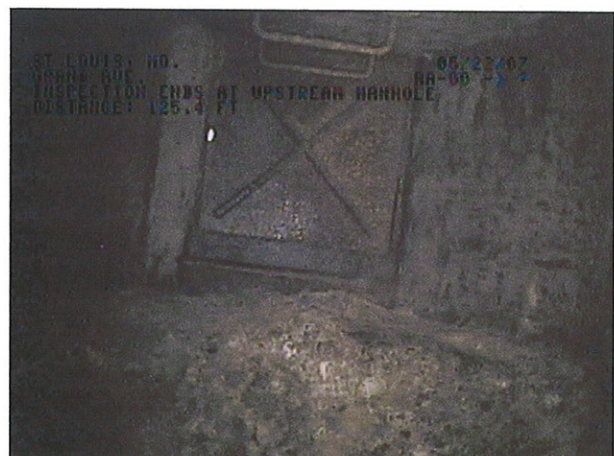
IMAGE: 156a, TAPE #: EMA-1, 02:10:22
125.4FT, inspection ends at upstream manhole

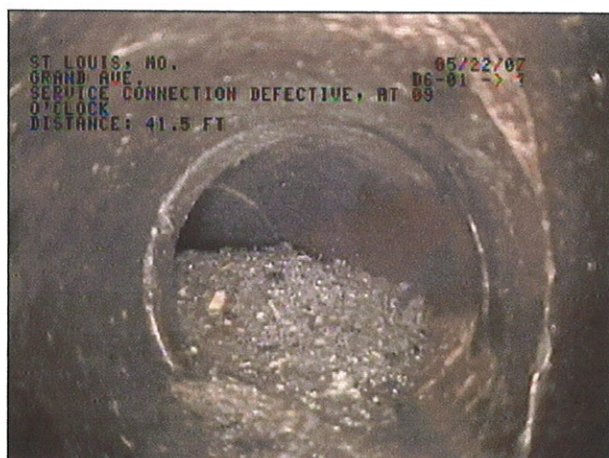
IMAGE: 164a, TAPE #: EMA-1, 02:13:00
41.5FT, service connection defective, at 09 o'clock

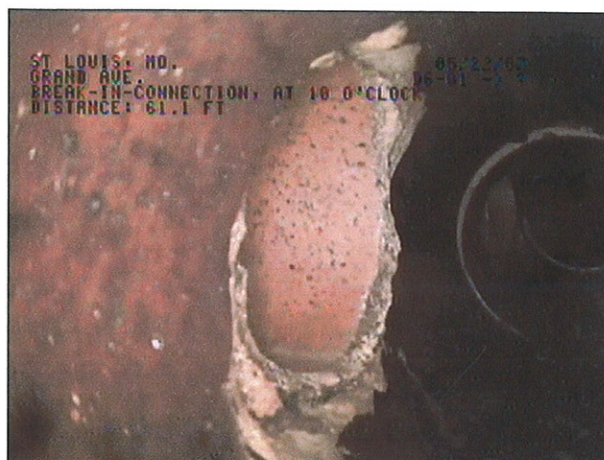
IMAGE: 167b, TAPE #: EMA-1, 02:14:03
61.1FT, break-in-connection, at 10 o'clock

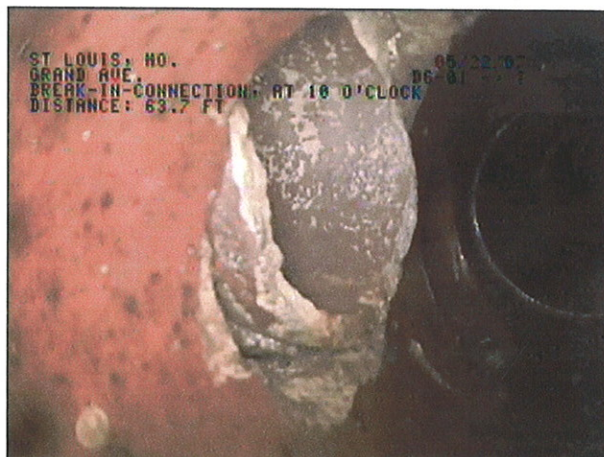
IMAGE: 168b, TAPE #: EMA-1, 02:14:26
63.7FT, break-in-connection, at 10 o'clock

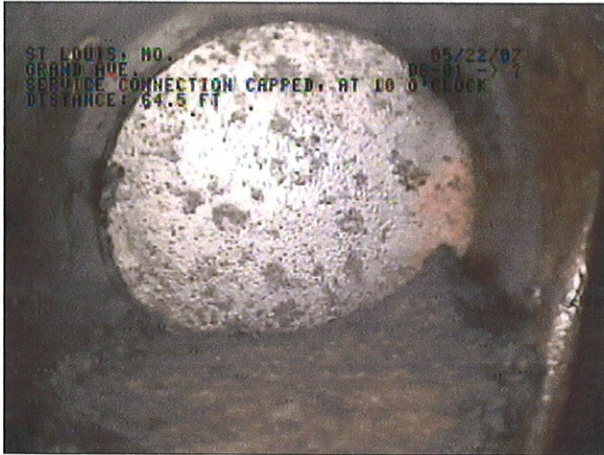
IMAGE: 169a, TAPE #: EMA-1, 02:14:44
64.5FT, service connection capped, at 10 o'clock

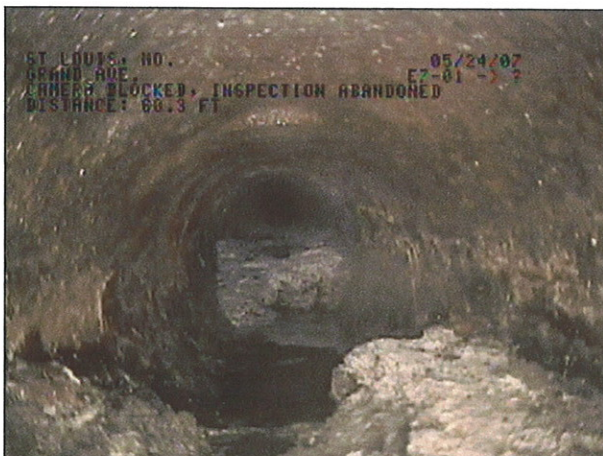
IMAGE: 181a, TAPE #: EMA-1, 02:22:29
60.3FT, camera blocked, inspection abandoned

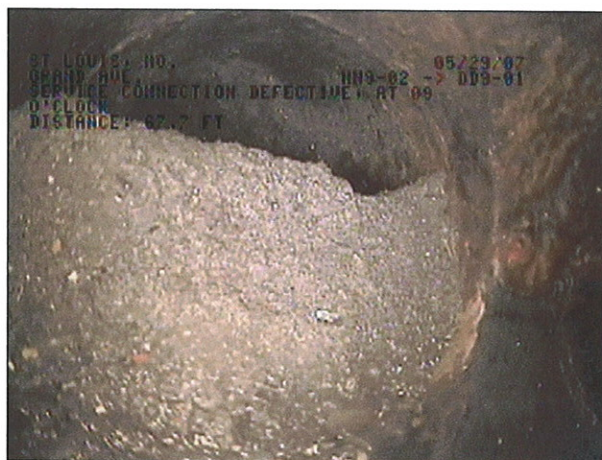
0.00	0	inspection begins at downstream manhole	02:22:35	182a	0
	44.50	0	pipe bends right	02:24:49		0
	67.70	160	service connection defective, at 09 o'clock	02:25:30	184a	1
	81.80	0	inspection ends at upstream manhole	02:26:55	185a	0

IMAGE: 184a, TAPE #: EMA-1, 02:25:30
67.7FT, service connection defective, at 09 o'clock

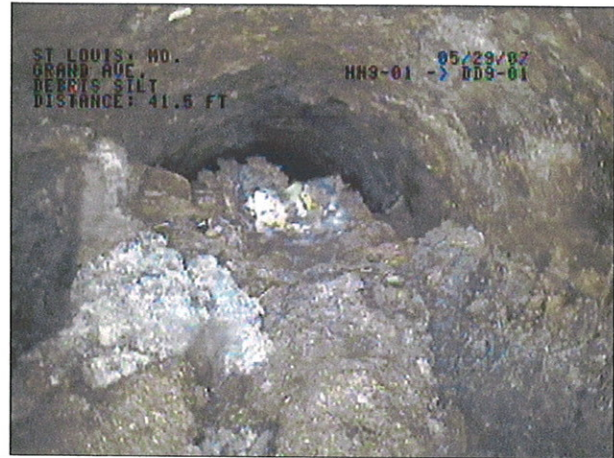
IMAGE: 187a, TAPE #: EMA-1, 02:29:35
41.5FT, debris silt

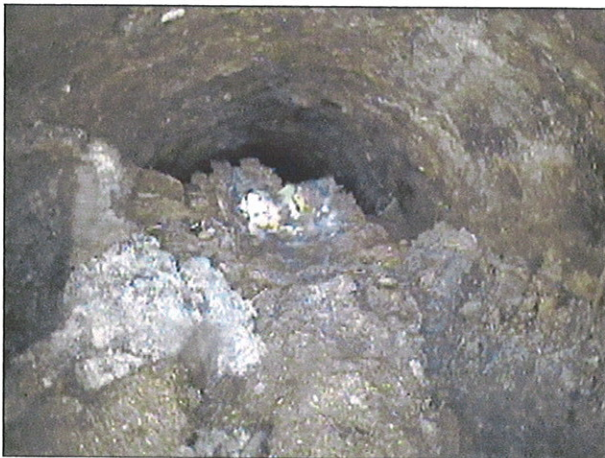
IMAGE: 188a, TAPE #: EMA-1, 02:29:42
41.5FT, camera blocked, inspection abandoned
